**DLM CN2-210-2**

**MP 3.9 2/18/2010**

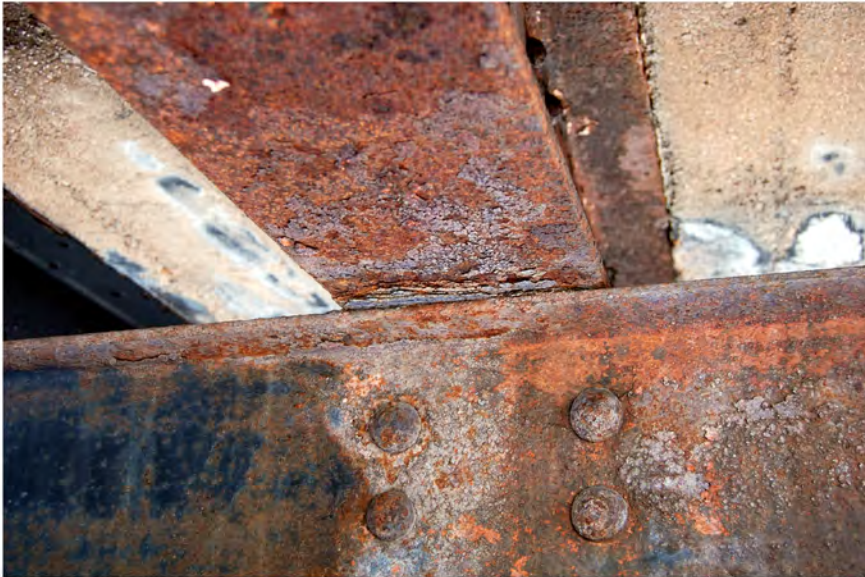
**PACK RUST AT GIRDER/CAP CONNECTION**

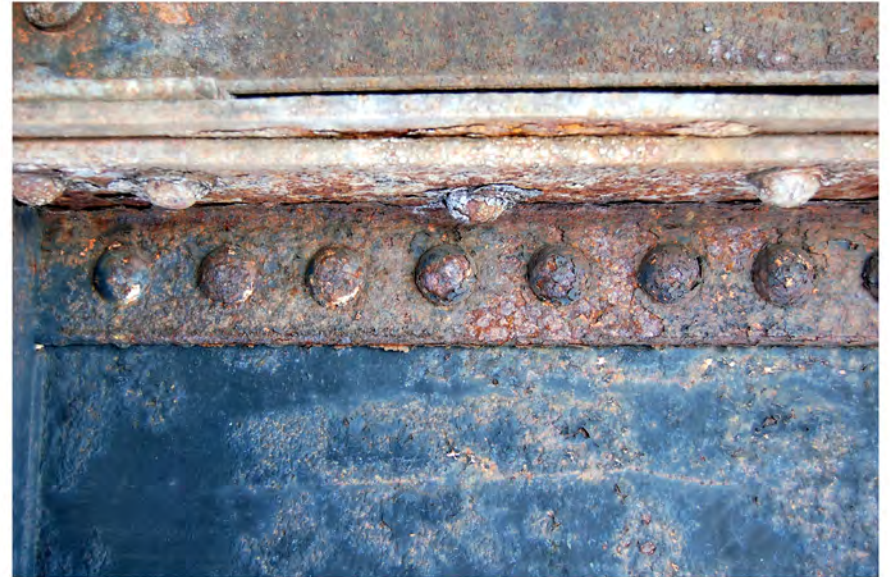
**SECTION LOSS TO TOP FLANGE OF BENT CAP**

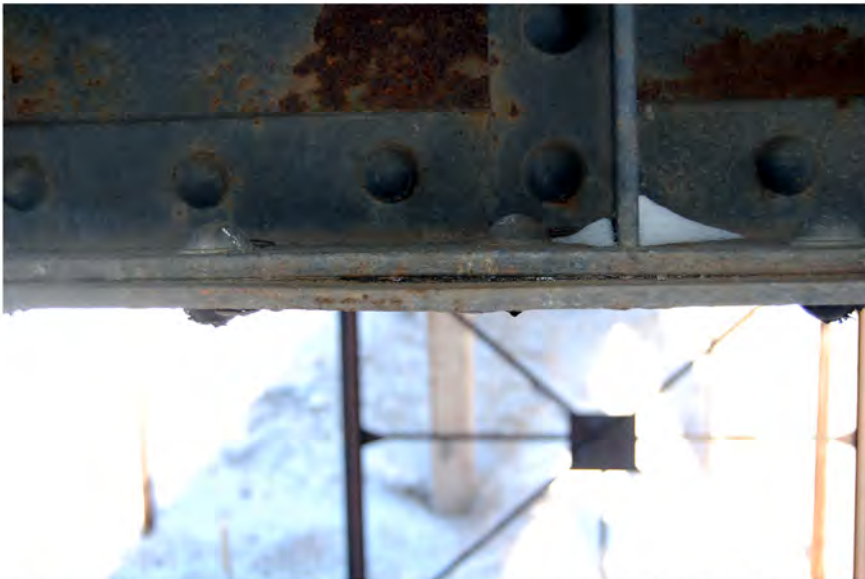
**PACK RUST OF COVER PLATE SOUTH BENT CAP**

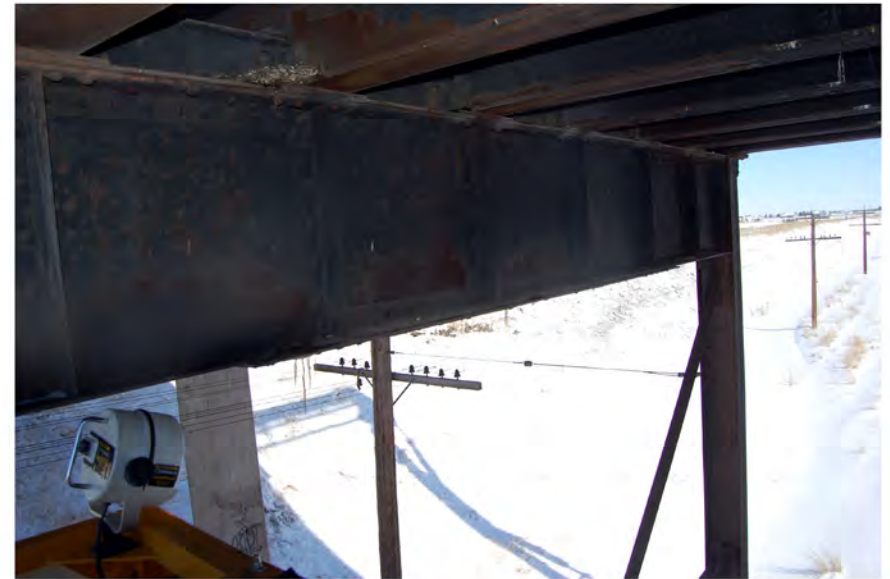
**RUST ON NORTH BENT CAP**

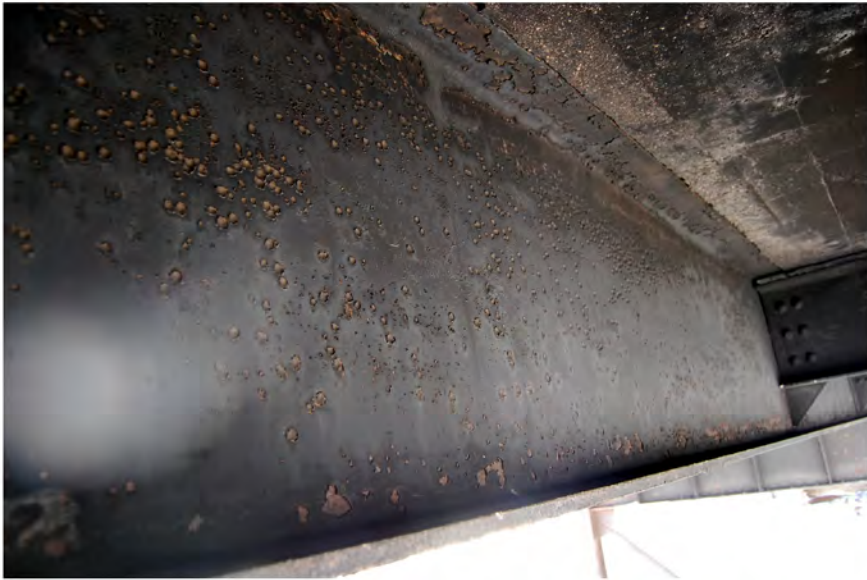
**PITTING OF CENTER SPAN GIRDER**

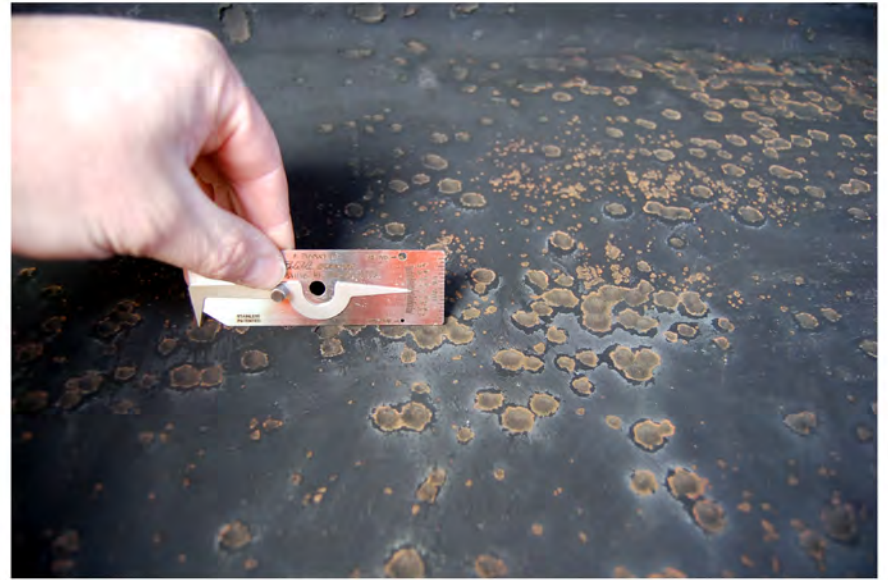
**GIRDER PITTING MEASURE 1/16" DEEP**

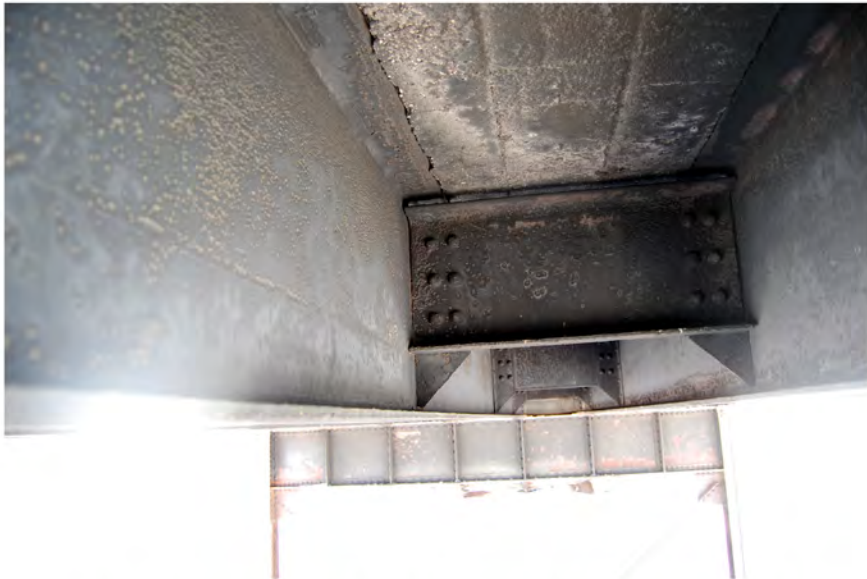
**GIRDER AND DIAPHRAGMS PITTING  
IN CENTER SPAN**

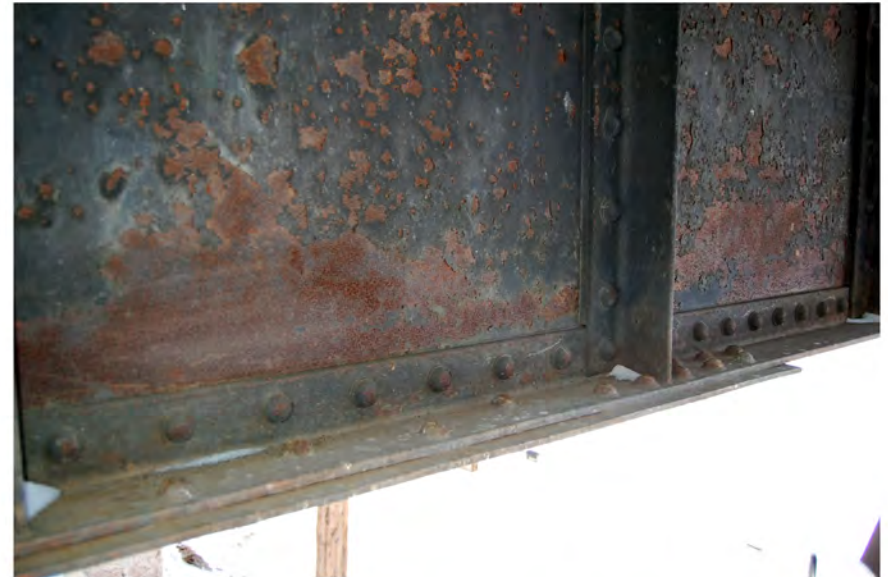
**RUST ON NORTH BENT CAP**

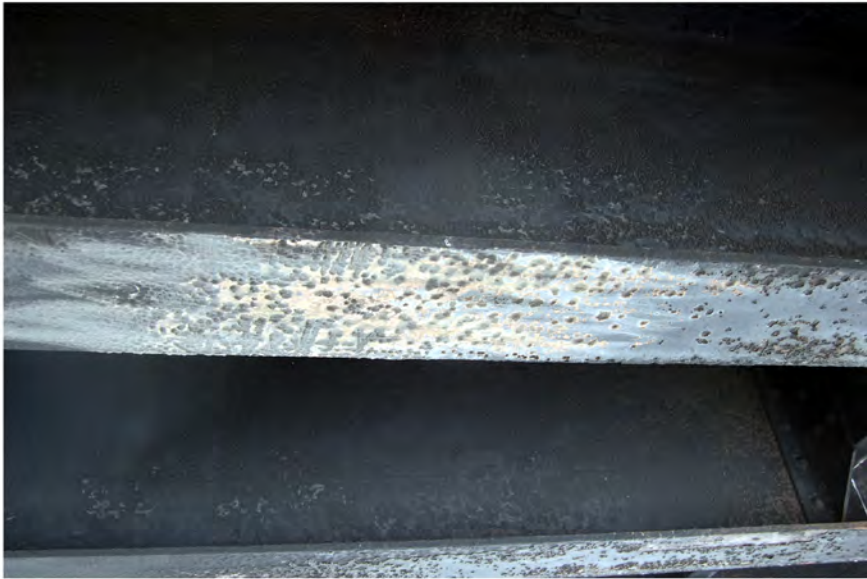
**RUST PITTING ON BOTTOM FLANGE OF CENTER SPAN GIRDERS**

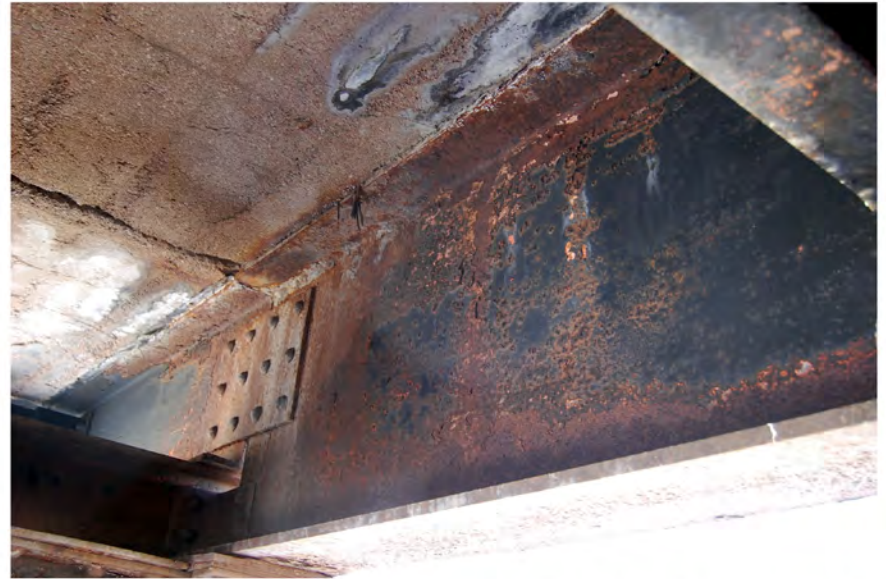
**RUST ON GIRDER ENDS UNDER DECK JOINTS**

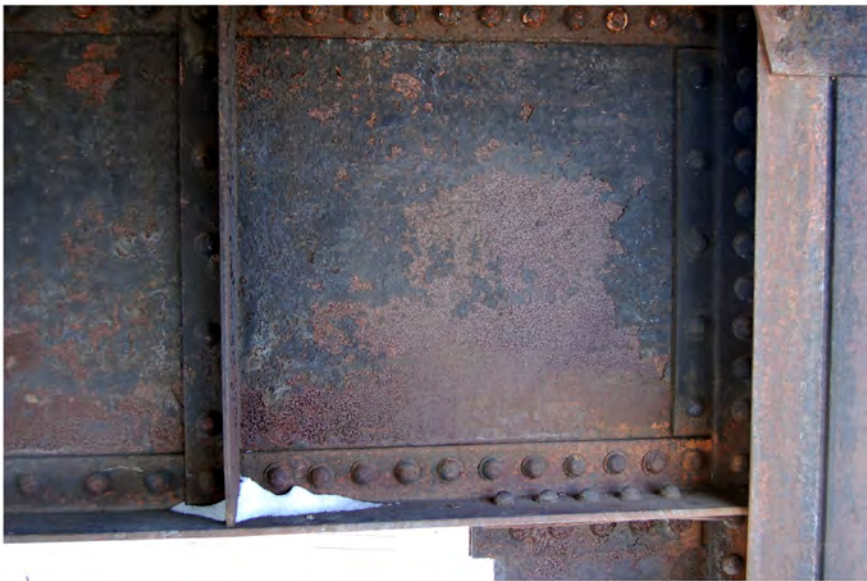
**RUST ON BENT CAP**

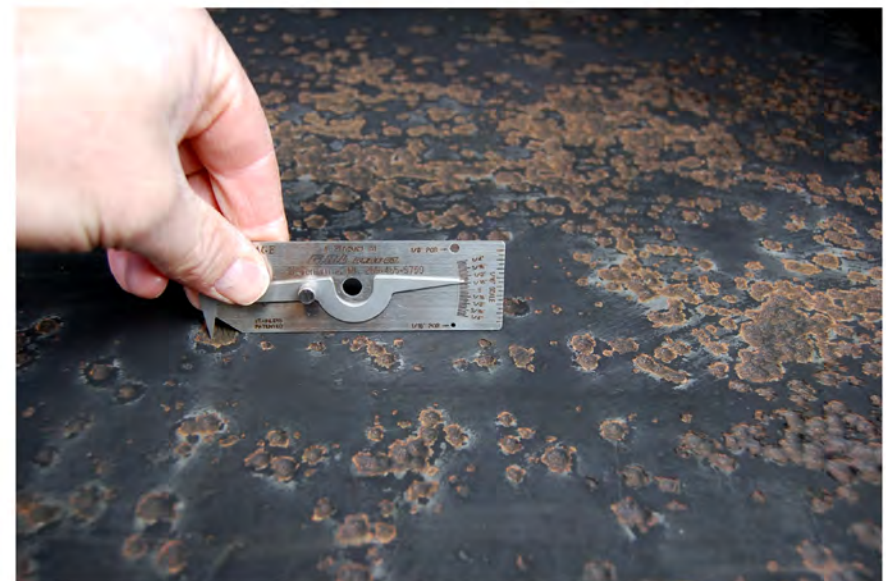
**RUST PITTING 1/16" DEEP**

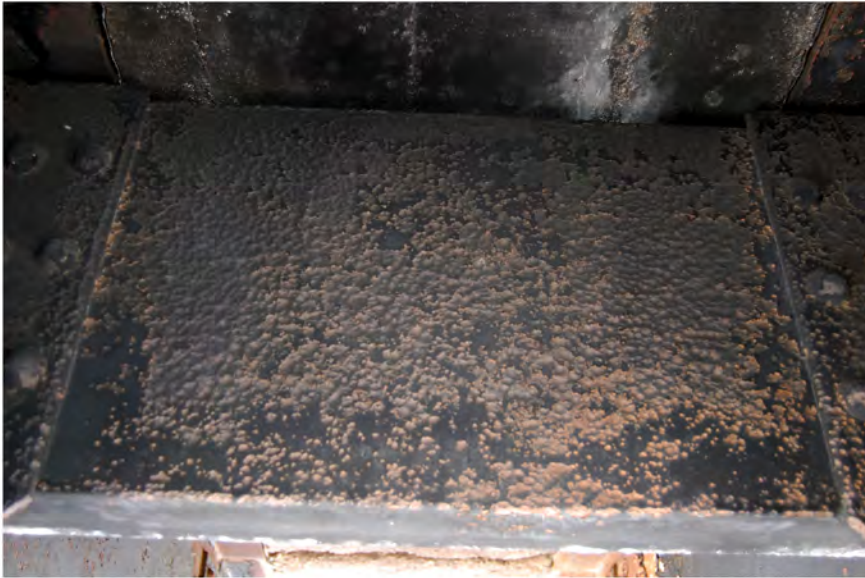
**RUST PITTING OF DIAPHRAGM**

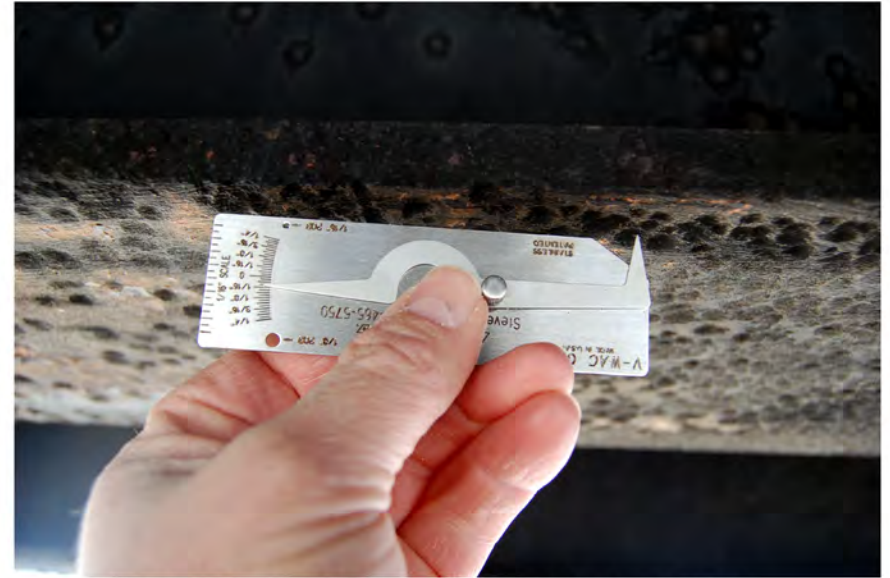
**RUST PITTING OF BOTTOM FLANGE**

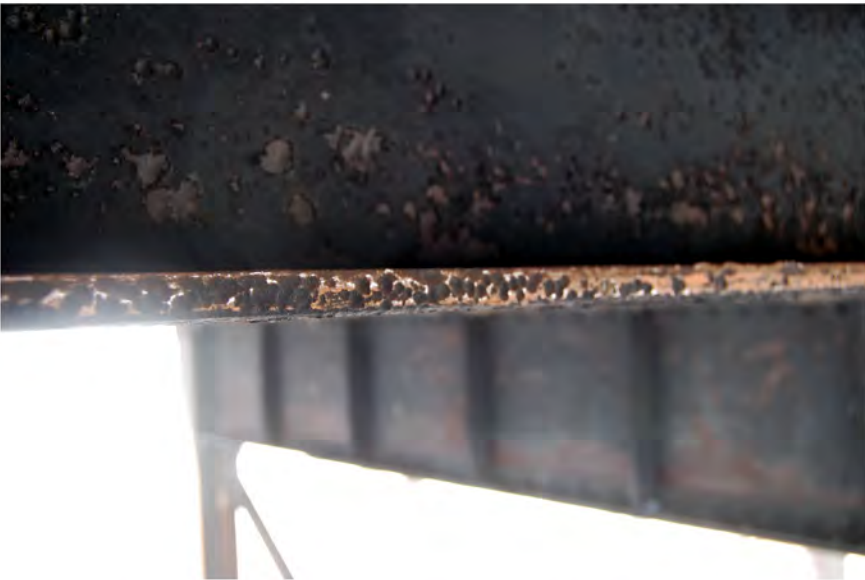
**RUST PITTING OF BOTTOM FLANGE**

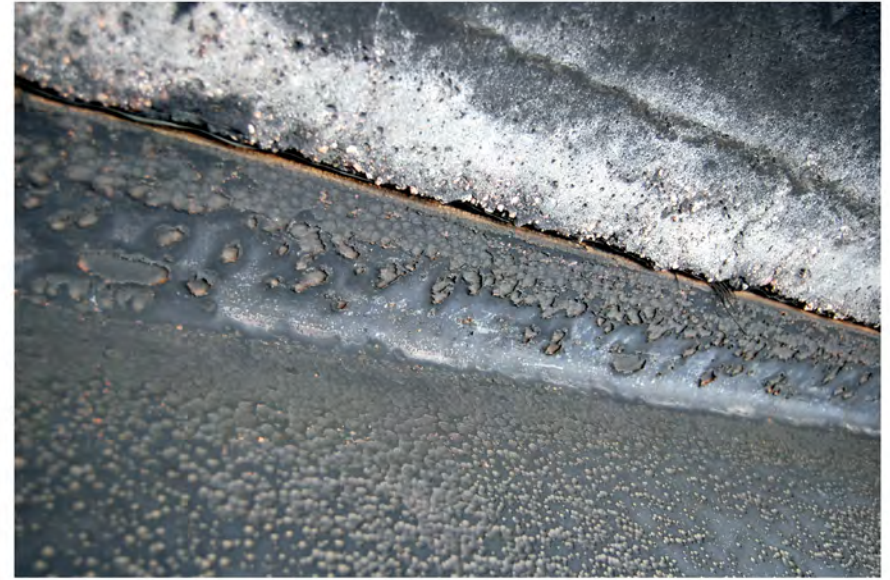
**RUST PITTING OF TOP FLANGE AND WEB**

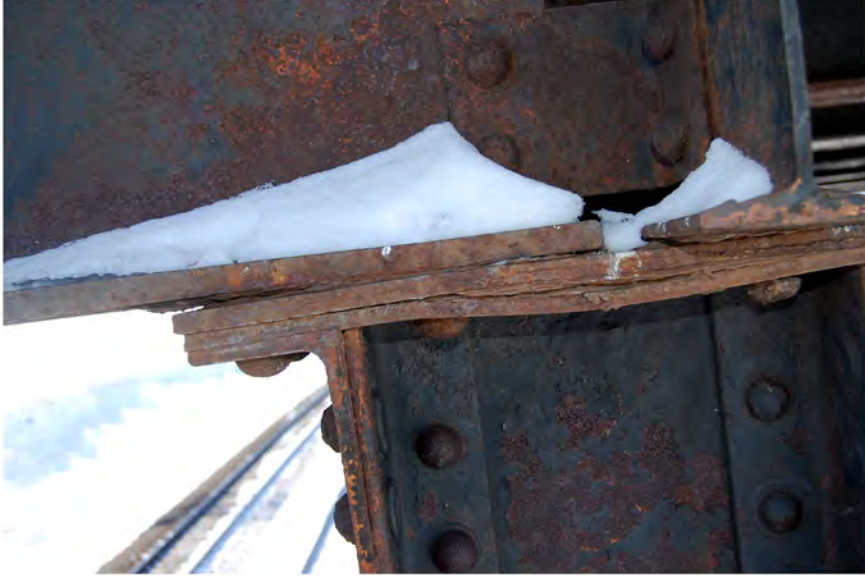
**PACK RUST AT BENT/GIRDER CONNECTION**

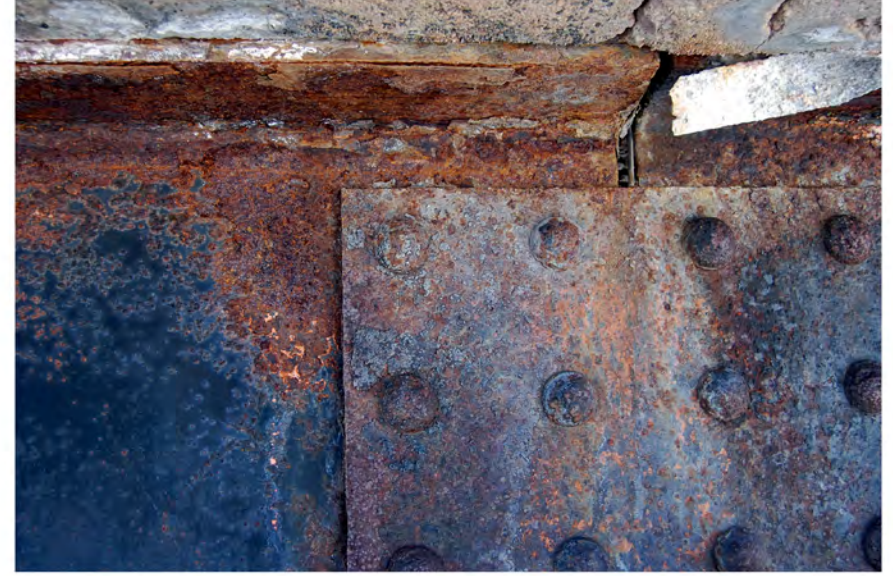
**RUST W/SECTION LOSS TO GIRDER  
ENDS UNDER DECK JOINT**

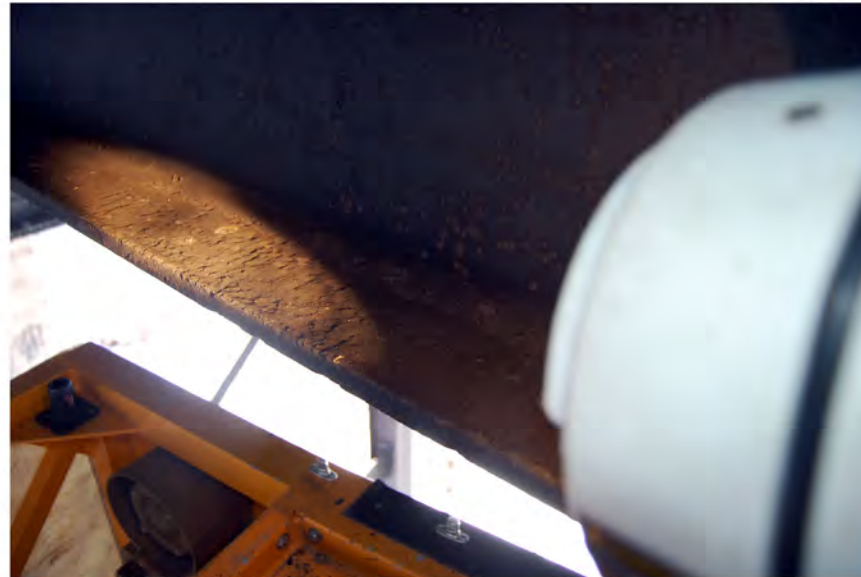
**SECTION LOSS TO TOP OF BOTTOM  
FLANGE OF CENTER SPAN GIRDER**

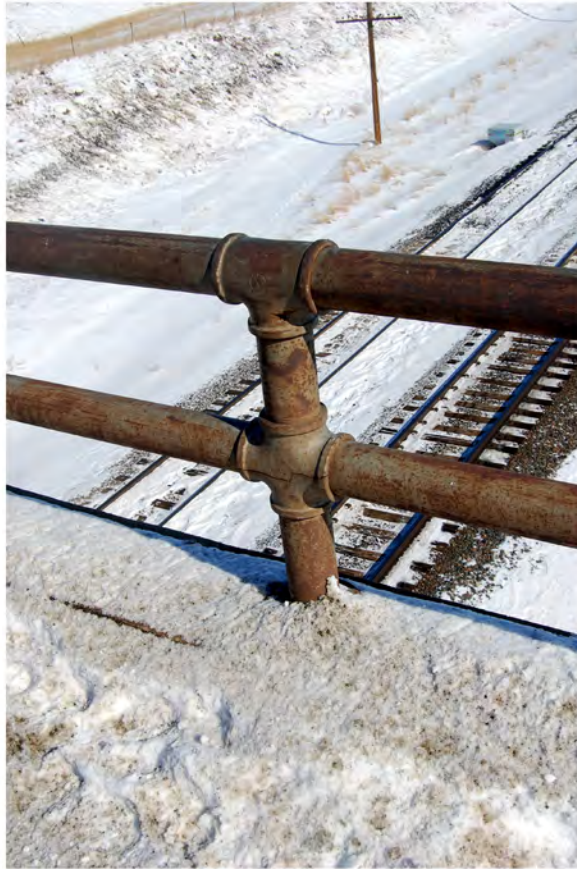
**COLLISION DAMAGED RAIL POST**

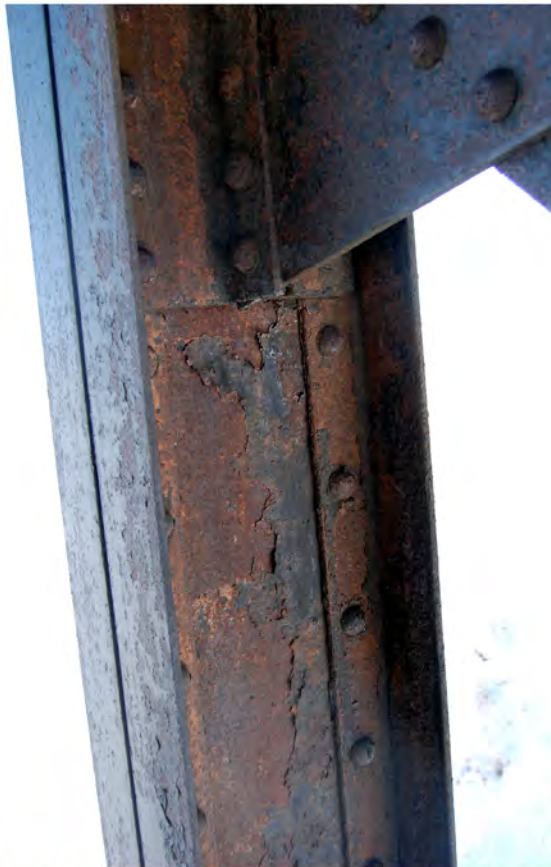
**RUST W/SECTION LOSS AT TOP  
OF STEEL COLUMN**
