Road Safety Audit Report

Dell Range Boulevard from Powderhouse Road to College Drive & Prairie Avenue from Powderhouse Road to Dell Range Boulevard

June 2013

Field Review Date: April 23 to 24, 2013

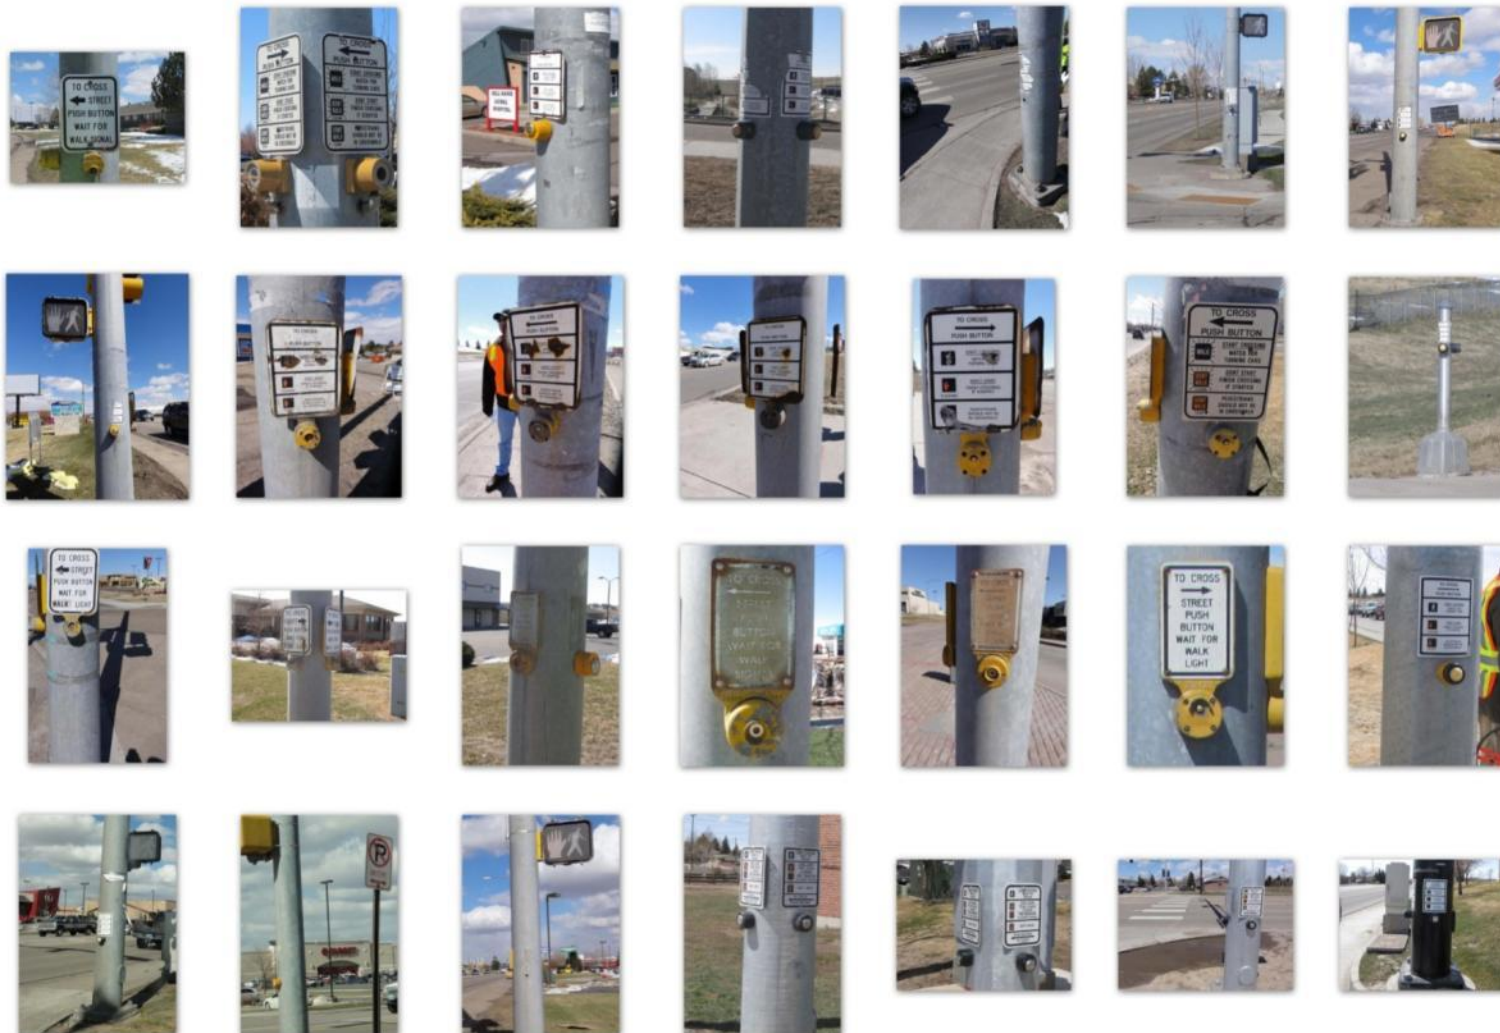
Exhibit 10 Example of Pedestrian Signal Equipment Variation along Dell Range Boulevard Corridor

The newer signals at Moran Avenue and Ridge Road have countdown signals on all approaches. The other signalized intersections have the older style pedestrian signal indications without countdown (See Exhibit 10). The RSA team also noted many of the pedestrian push button detectors and the pedestrian actuation signs are aged and some are not legible.

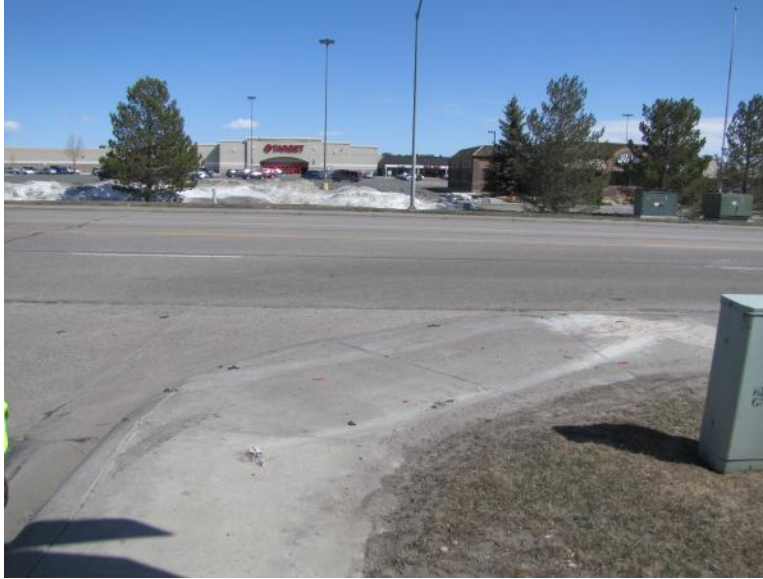
Exhibit 16 Sidewalk in SE Corner of Intersection

Issue: Narrow Sidewalk Width in SE Corner

Narrow sidewalk width in SE corner	Powderhouse Road to Stillwater Avenue (W)	Category I	Widen sidewalk to provide minimum clear width of 4 feet.
Signal pole located in pedestrian path	Powderhouse Road to Stillwater Avenue (W)	Category I	Realign concrete curb to provide minimum clear width of 4 feet.
Inaccessible pedestrian push button	Powderhouse Road to Stillwater Avenue (W)	Category I	Provide hard surface access to the pedestrian push buttons, extend the push button off the existing pole or relocate the push buttons to a separate pole having hard surface access.
Cracked sidewalk in SW corner	Powderhouse Road to Stillwater Avenue (W)	Category I	Replace section of concrete sidewalk.
Cracked sidewalk in south	Stillwater Avenue (W) to Driftwood Drive	Category I	Replace section of concrete sidewalk.
Intersection volumes may not warrant signal	Dell Range Boulevard/Driftwood Drive	Category I	Conduct signal warrant study to determine if the signal should be removed.

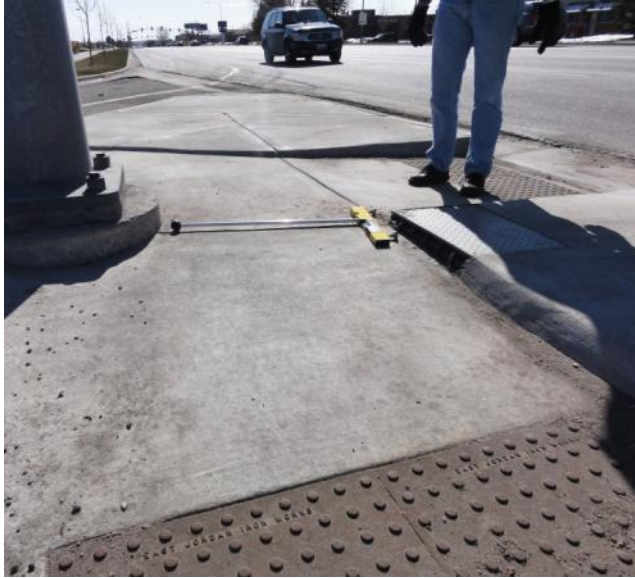
**Exhibit 17 Pedestrian Path in Northeast
Corner of Dell Range/Stillwater
Avenue Intersection**

Issue: Signal Pole Located in Pedestrian Path

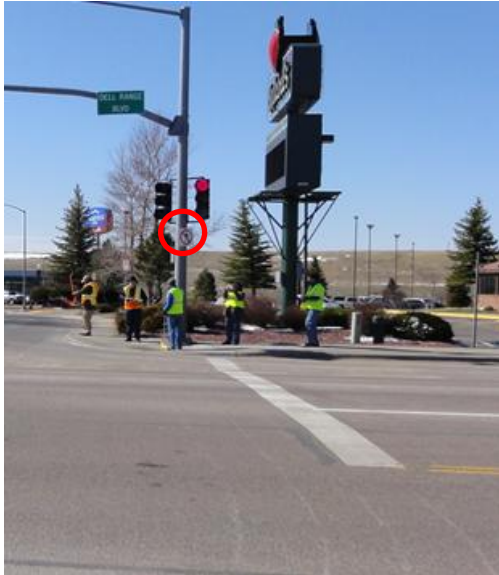
Exhibit 18 Looking South on West Leg of Intersection

Issue: No Pedestrian Crossing on West Leg

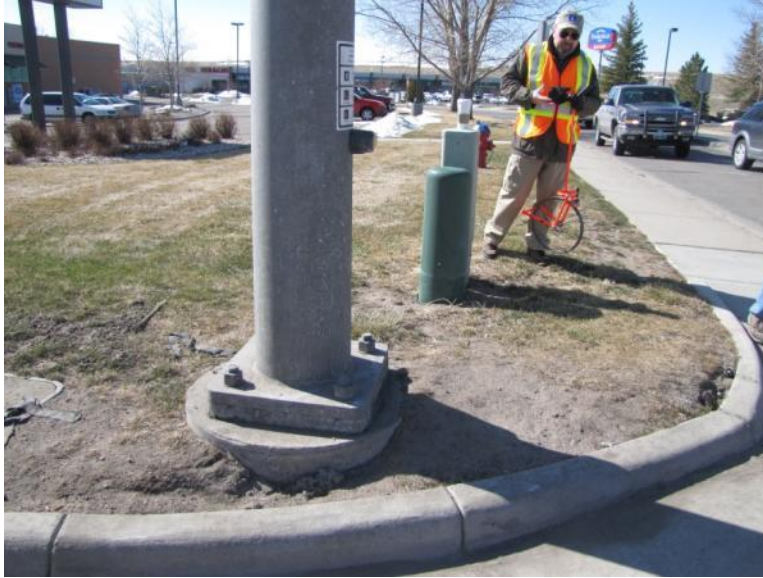
Exhibit 19 Existing Pedestrian Push Button in SE Corner of Intersection

Issue: Inaccessible Pedestrian Push Button

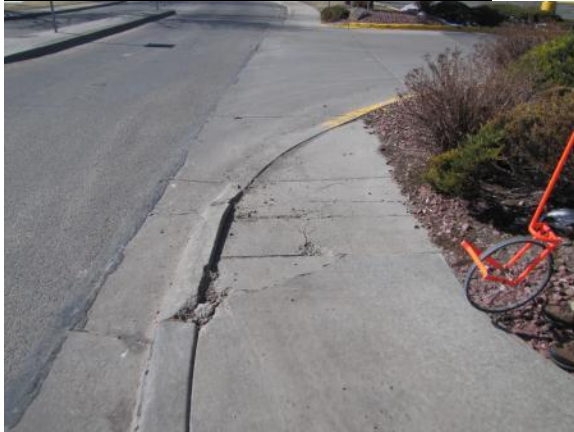
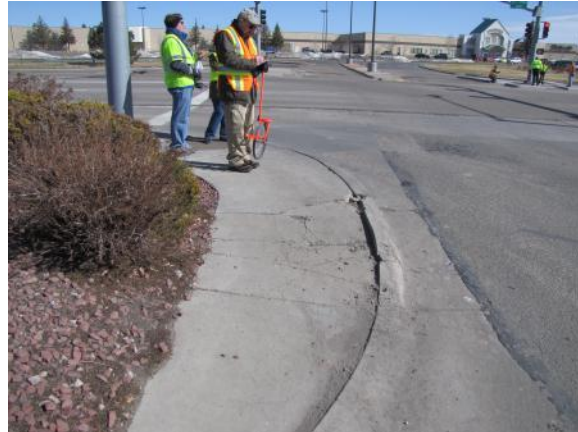
Issue: Cracked Sidewalk in SW Corner

Exhibit 20 Cracked Sidewalk in SW Corner Looking South

Exhibit 21 Cracked Sidewalk in SW Corner Looking North

The concrete sidewalk in the southwest corner of the intersection is cracked making it difficult for a person in a wheelchair to traverse.

Replace this section of concrete sidewalk.

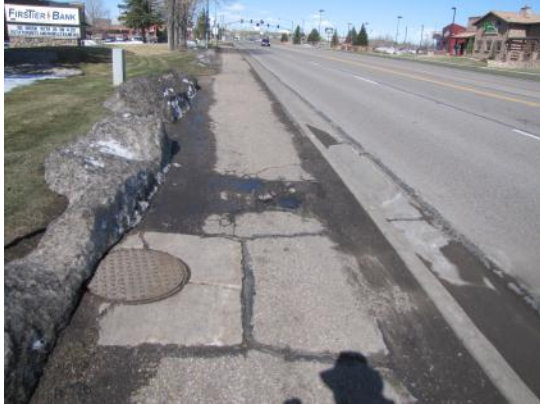
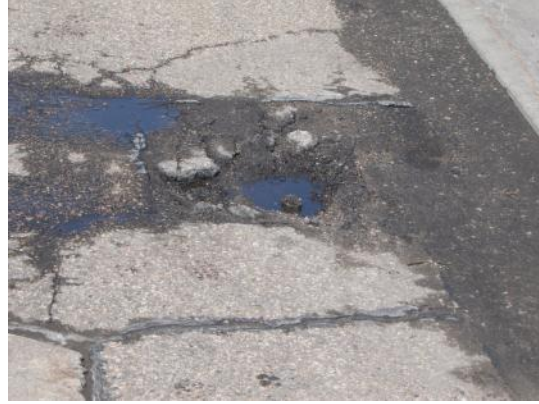
Issue: Cracked Sidewalk

Exhibit 22 Cracked Asphalt Sidewalk – South Side

Exhibit 23 Pot Hole in Asphalt Sidewalk

Asphalt sidewalk has pot hole and cracking allowing for water to pond. Similar conditions were seen in two other locations in this segment. This can make it difficult for wheelchair and visually impaired persons to traverse.

Replace these sections of the sidewalk.

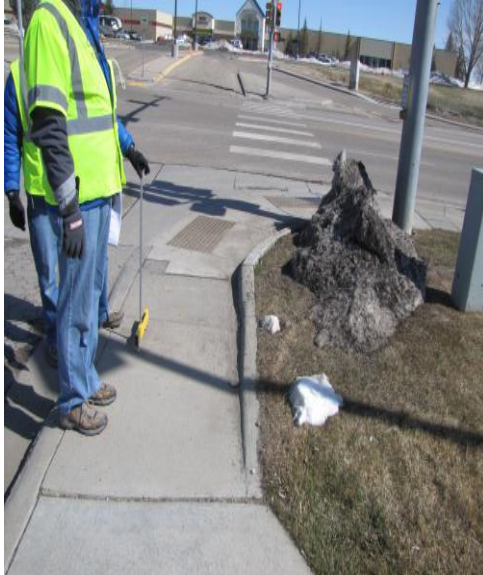
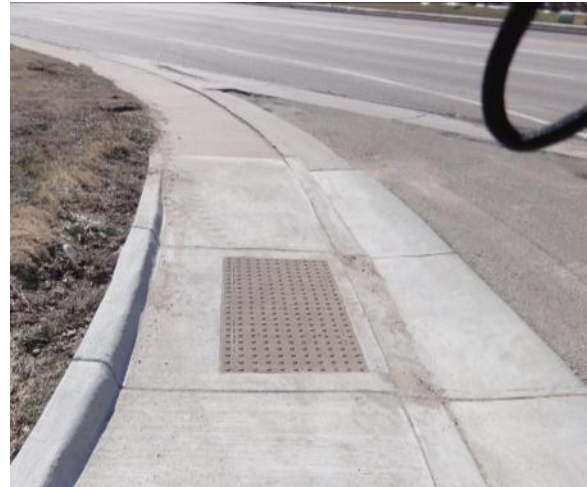
Issue: Sidewalk Width in SE and NE Corners

Exhibit 29 Sidewalk in SE Corner

Exhibit 30 Sidewalk in NE Corner

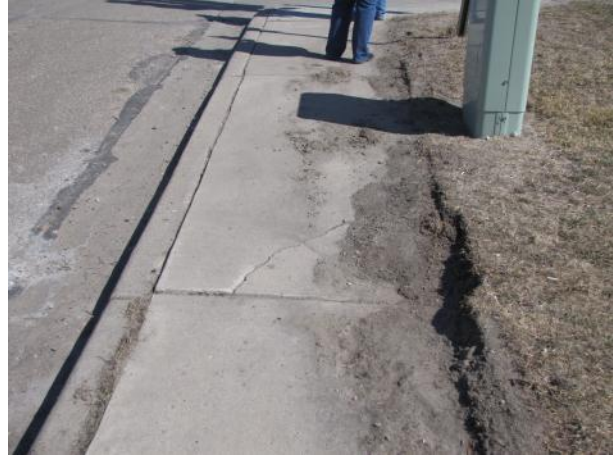
Exhibit 34 Dirt Blocking Sidewalk – SW Corner

Dirt has spilled into the sidewalk reducing the effective width to less than 4-ft and creating a potential tripping hazard for pedestrians.

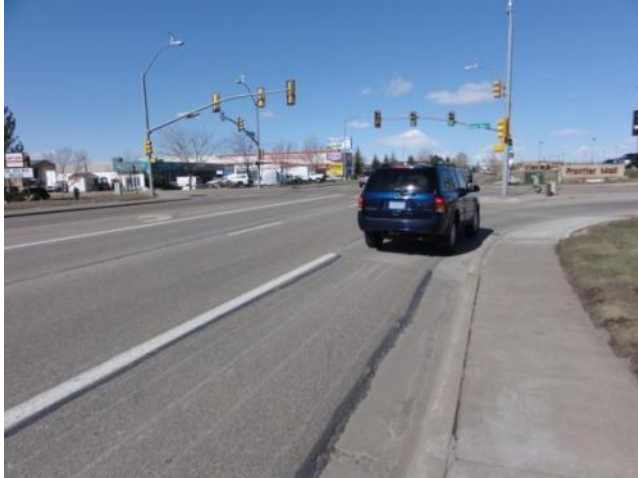
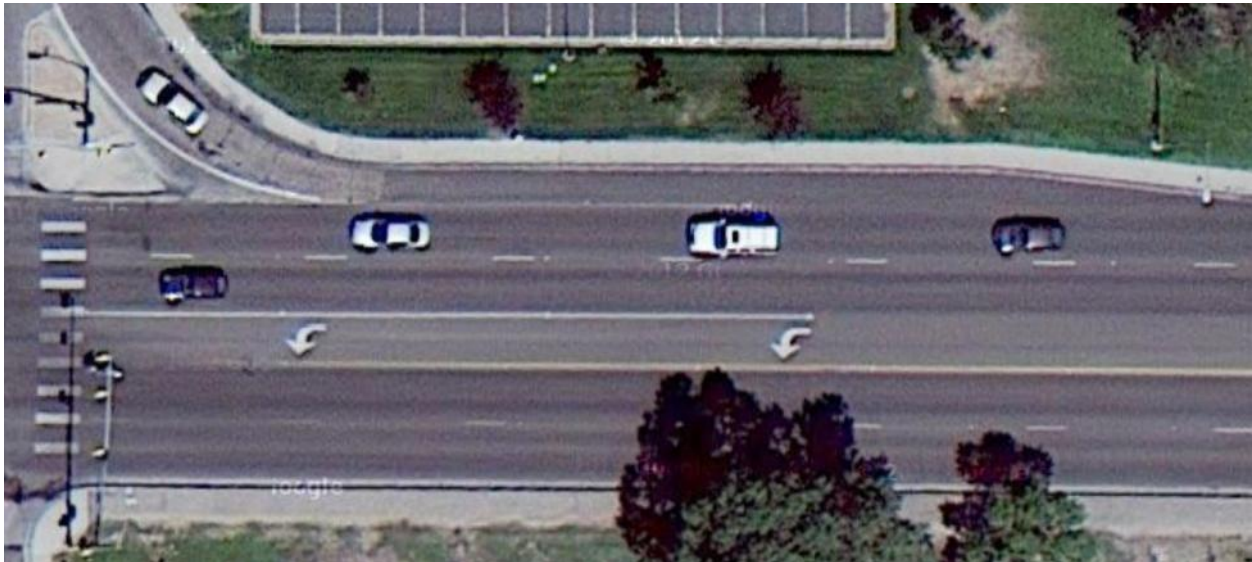
Issue: Westbound Right-Turn Lane Width

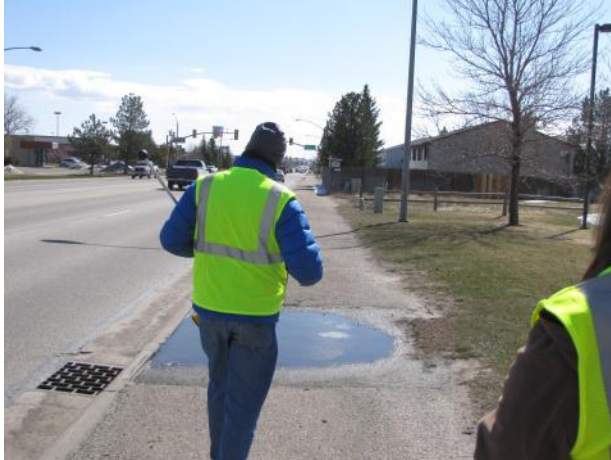
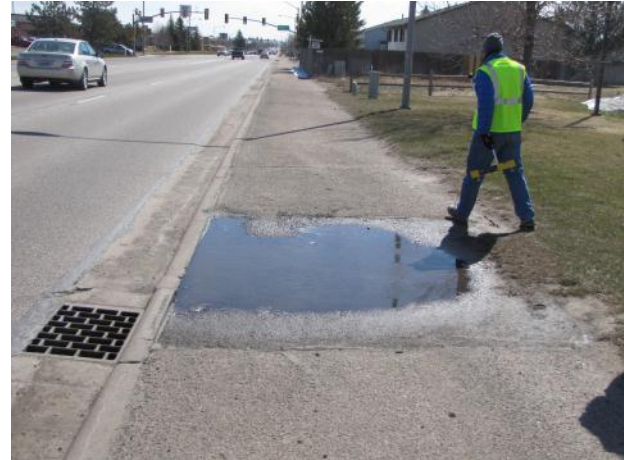
Issue: Water Ponding on Asphalt Sidewalk

Exhibit 44 Water Ponding on Sidewalk

Repair sidewalk to remove depression and drain to street.

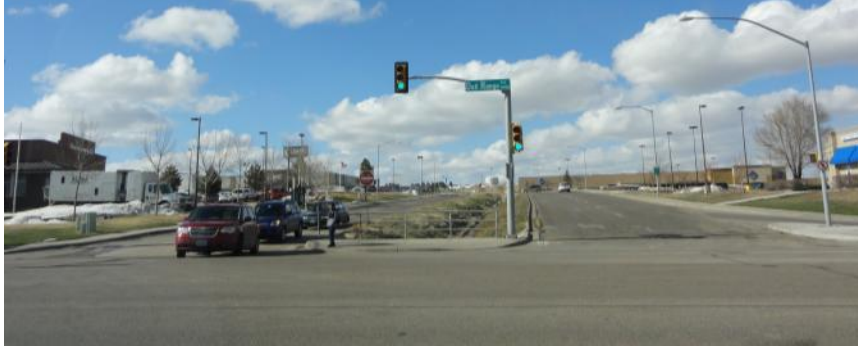
Exhibit 51 Looking North from Northbound Approach

Issue: Offset Intersection

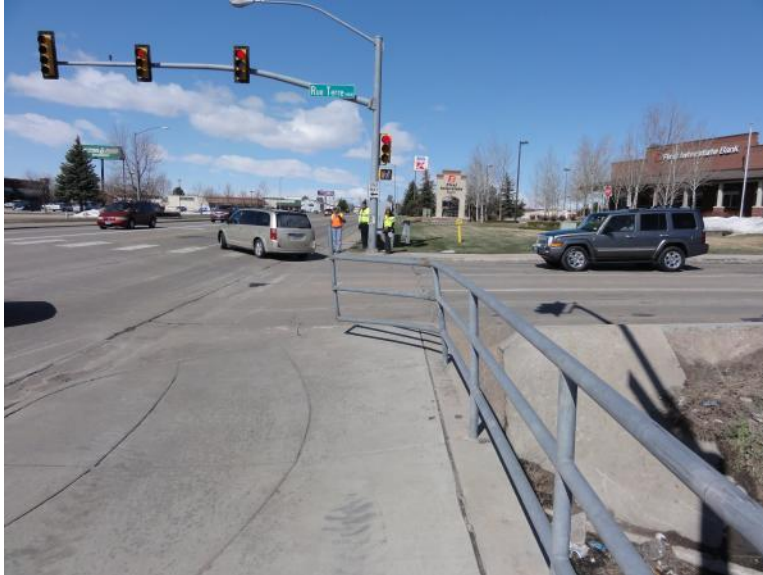
Exhibit 52 North Sidewalk Looking West

Issue: Railing Bent by Truck

Replace or repair railing.

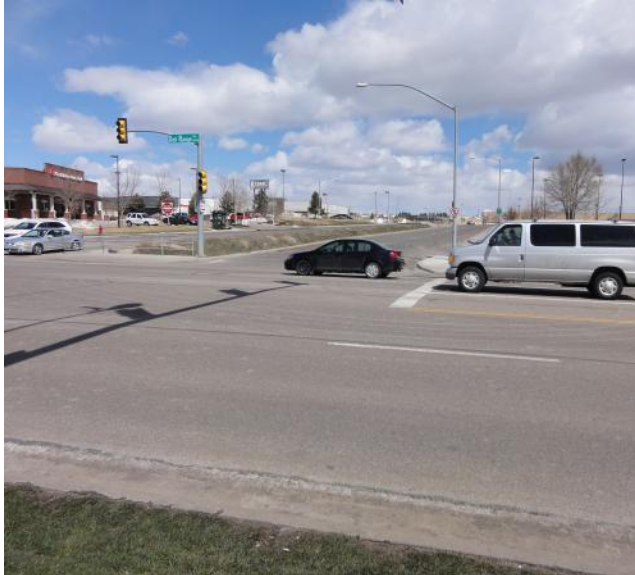
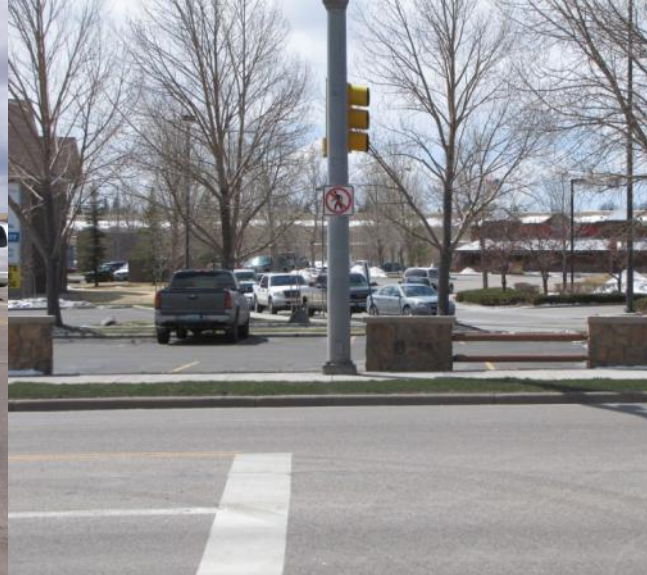
Issue: Missing Crosswalk on East Leg

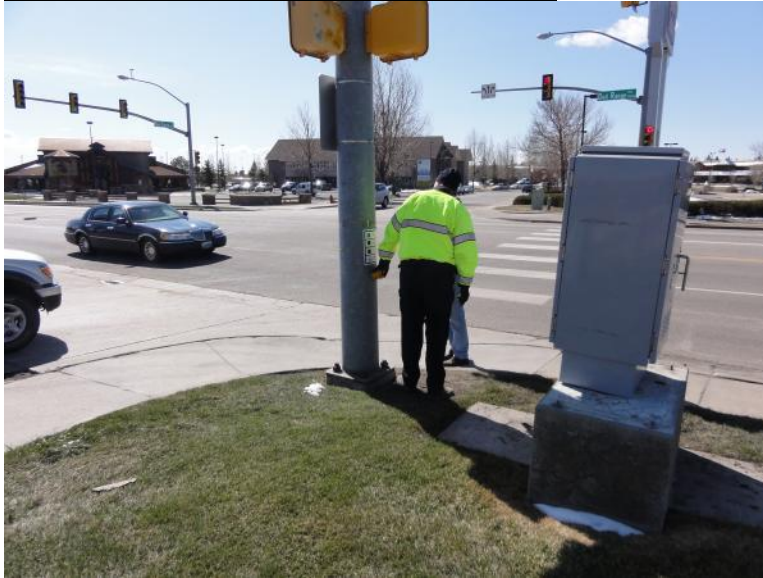
Issue: Inaccessible Pedestrian Push Button

Exhibit 55 NW Corner – Pedestrian Push Button Accessibility

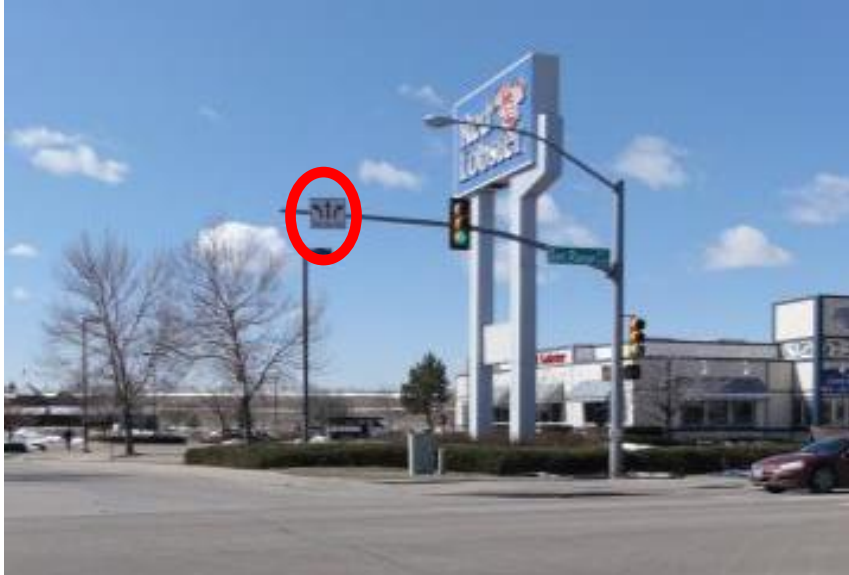
Issue: Poor Sign Retro-Reflectivity

Exhibit 56 Low Reflectivity of Channelization Sign Mounted to Mast Arm Signal Pole

Replace sign.

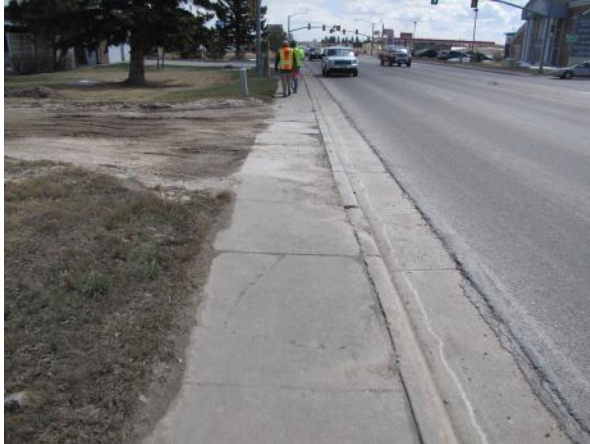
Exhibit 59 Driveway/Sidewalk north side

Issue: Sidewalk/Driveway Surface Condition

The driveway serving a dirt road to the north and behind the fire station also serves as a sidewalk. This driveway/sidewalk has become cracked and is ponding water. The joints have become uneven. Crossing this area as a pedestrian could be difficult especially if in a wheelchair.

Repair cracked concrete driveway/sidewalk. Consider extending driveway paving to the north to minimize the dirt getting onto the sidewalk.

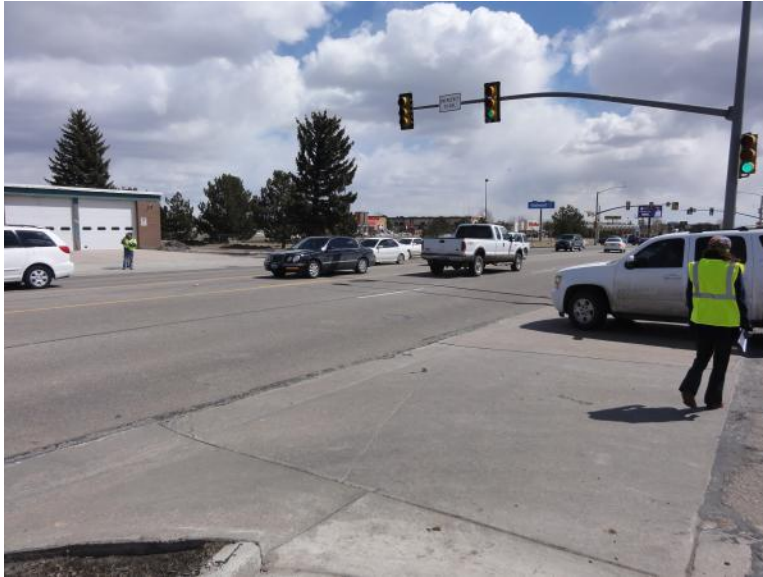
Exhibit 61 South Approach From SW Corner

Issue: Crosswalk on South Leg

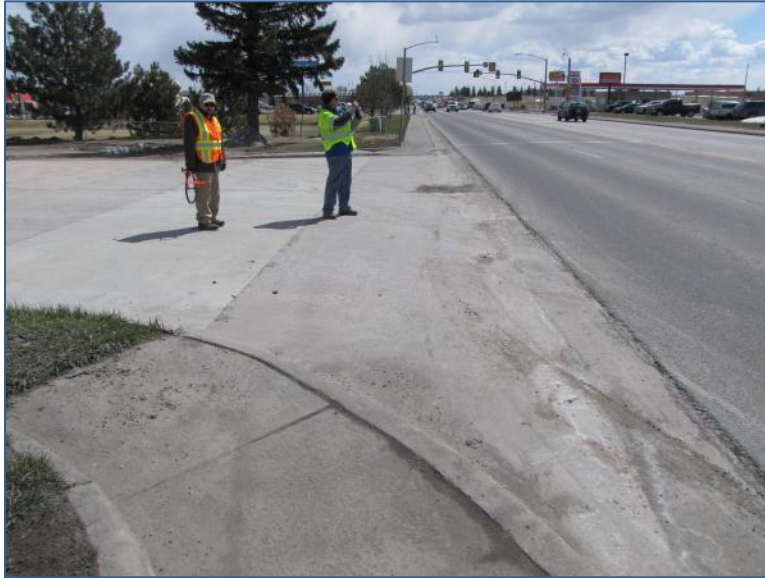
Exhibit 62 Northwest Side of Fire Station Driveway

Issue: Sidewalk curb lip to Fire Station driveway

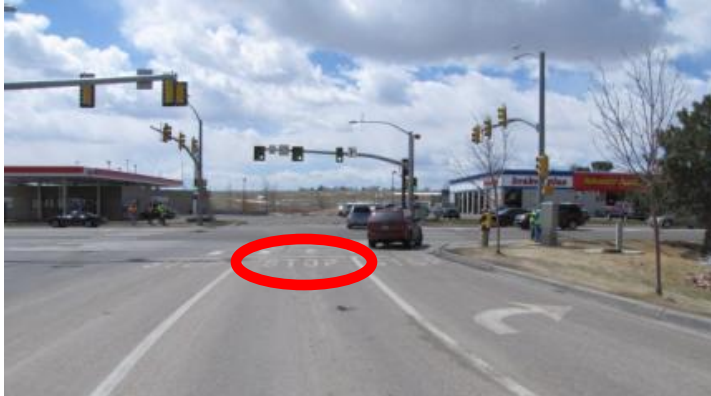
Exhibit 65 Looking South from North Approach

Issue: STOP Pavement Markings SB Approach

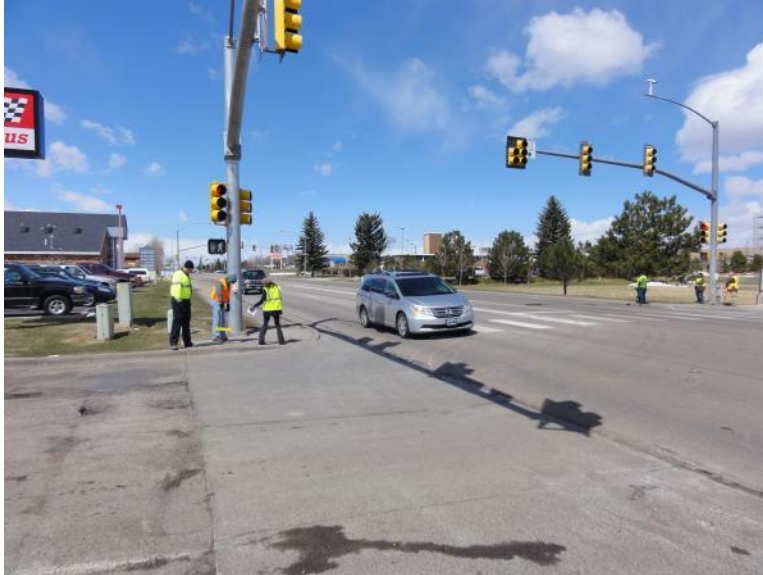
Exhibit 66 Looking West from SE Corner of Intersection

Issue: Crosswalk on South Leg

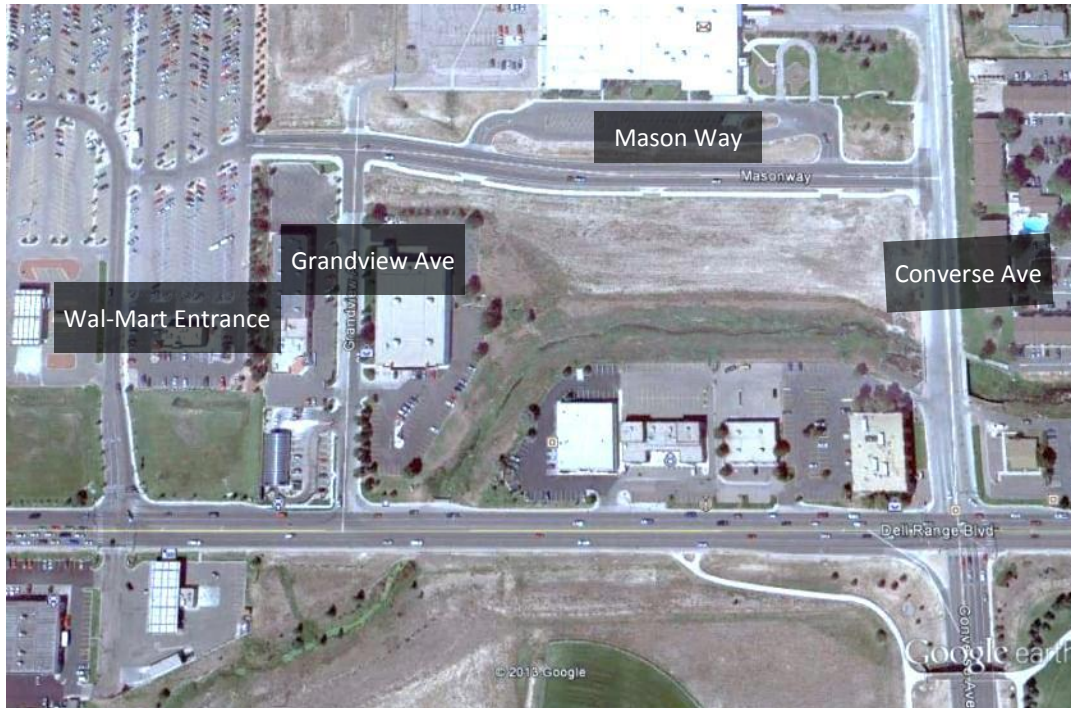
Exhibit 67 Google Earth Aerial of Grandview Avenue Area

Issue: Wal-Mart Westbound Queue Blocks Intersection

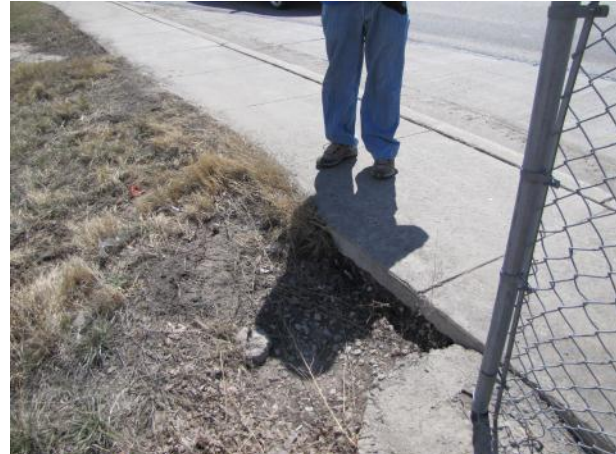
Exhibit 69 North side – sidewalk drop-off at box culvert – east of culvert

Extend the limits of the fence and repair fence.

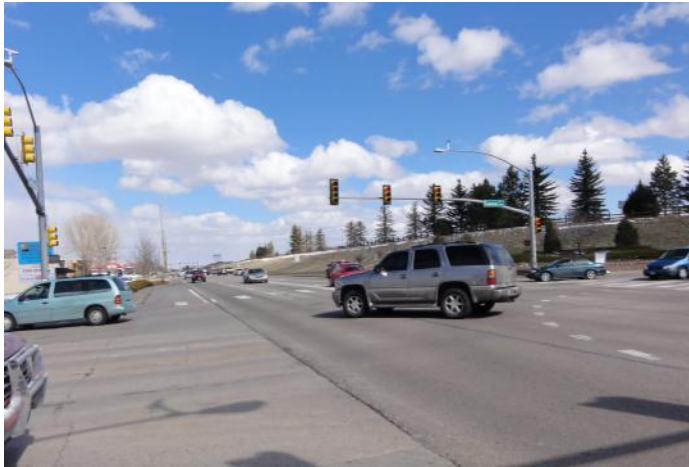
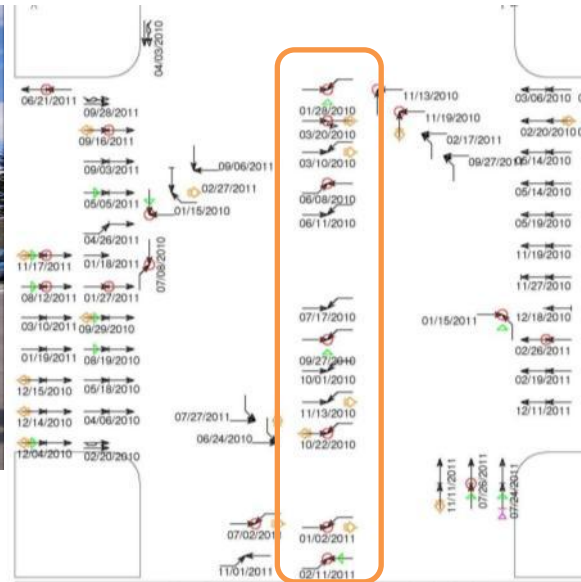
Issue: East-West Left Turn Crashes

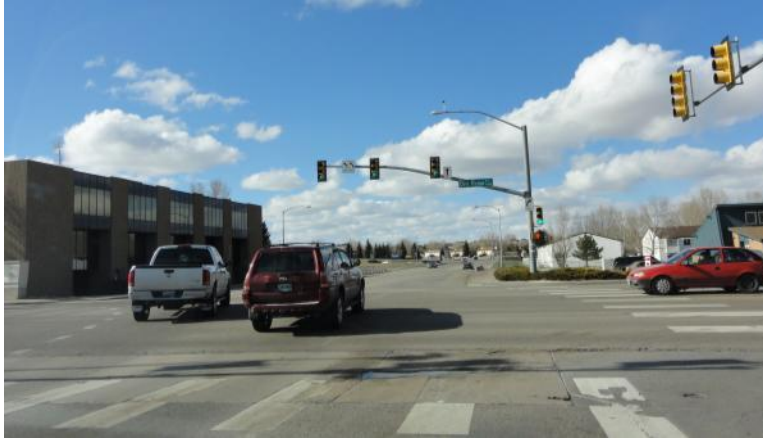
Exhibit 72 Looking North from South Leg of Intersection

Issue: Angle crashes at intersection

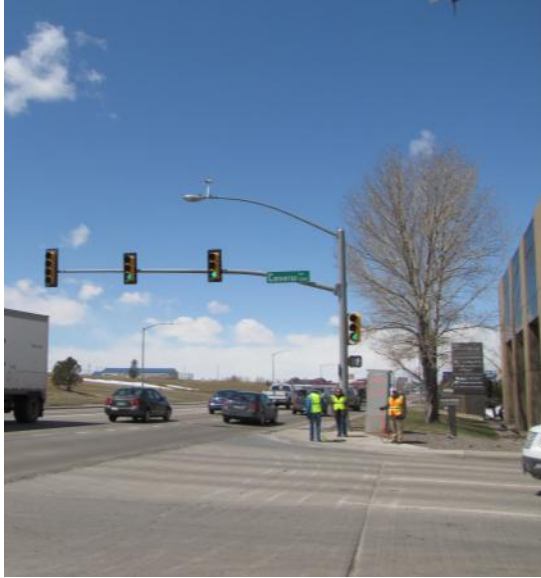
**Exhibit 73 Looking at North Crosswalk from
NE Corner**

Issue: North approach crosswalk

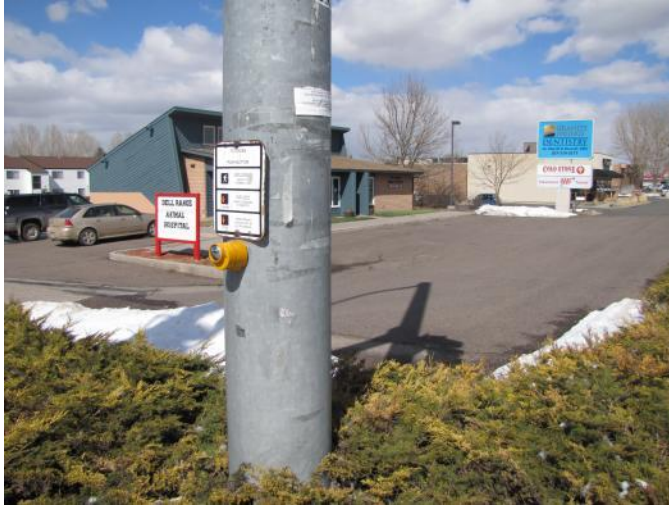
Exhibit 74 Signal Pole in NE Corner

Issue: Pedestrian Signal Not Operative

Repair

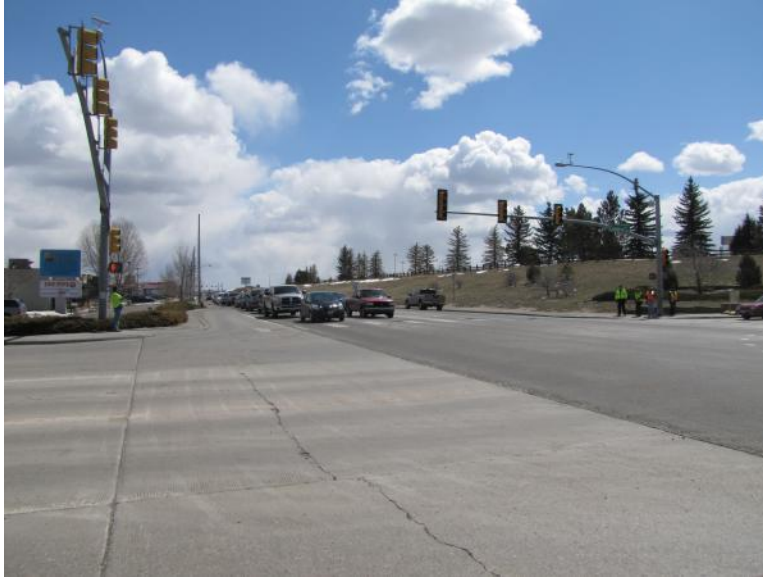
Exhibit 75 Looking East at Intersection from NW Corner

Issue: Corner Turn Radii – NE and NW corners

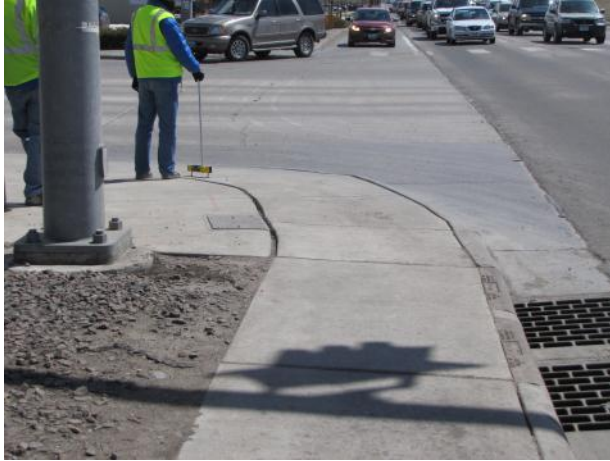
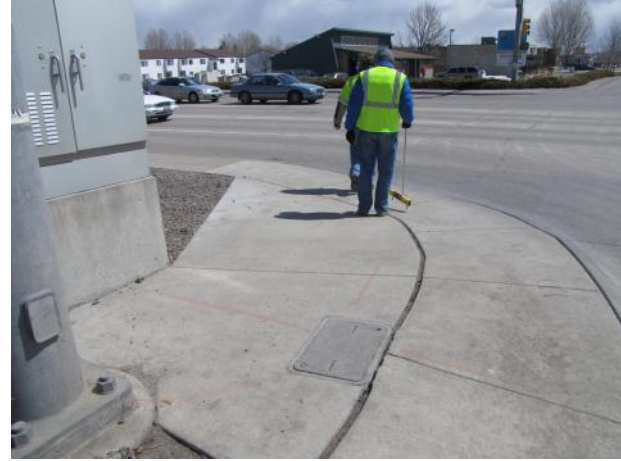
Issue: Northwest Corner Pedestrian Ramp Slopes

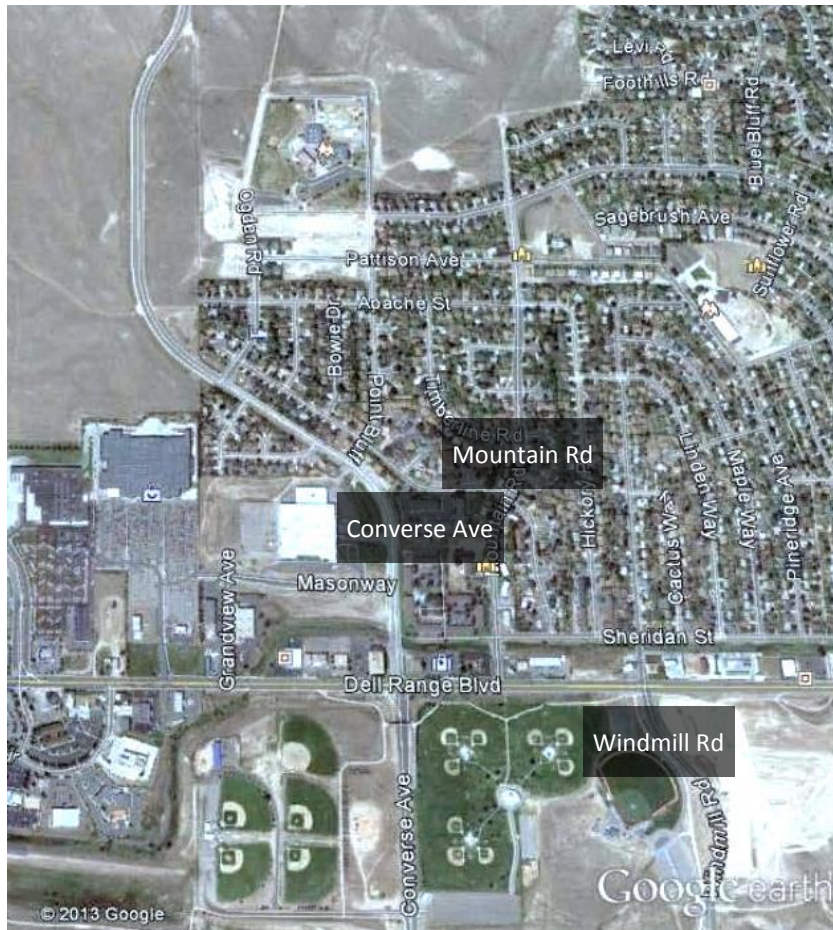
Exhibit 78 General Area around Mountain Road

Issue: Left-Turn Movements at Mountain Road

Mountain Road has full, unsignalized access to Dell Range Boulevard. The RSA team observed westbound traffic queuing from Converse Avenue to east of Mountain Road in the mid-afternoon. The approximate 625-foot spacing between intersections also limits the deceleration and queue storage for the westbound left turn to Converse Avenue. This intersection has had a fatal crash involving an eastbound left-turn vehicle and three other injury crashes involving left-turns to/from Mountain Road. Left turns from Mountain Road to eastbound Dell Range Boulevard frequently required a two stage movement into the center two-way left-turn lane. As shown in Exhibit 78, there are alternatives in the existing street network for traffic to use to access Mountain Road, including Converse Ave or Windmill Road.

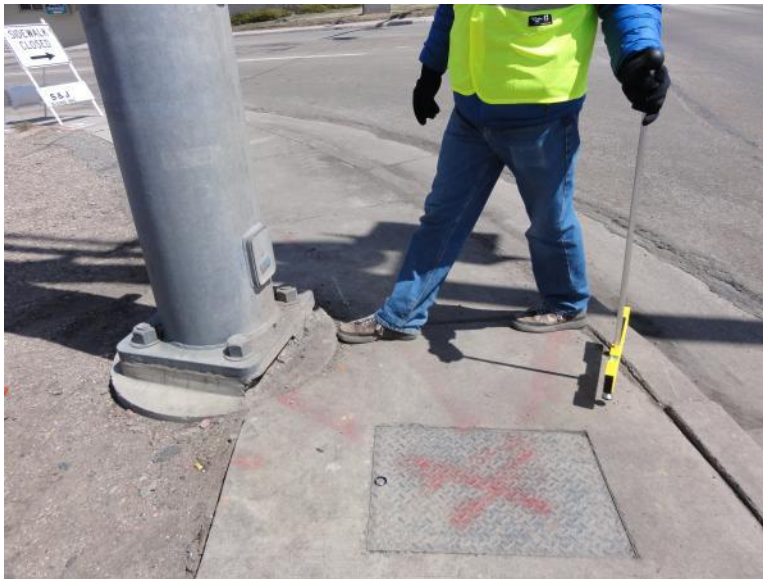
Exhibit 79 Signal Pole in NW Corner of Intersection

Issue: Signal Pole Located in Pedestrian Path

The signal pole and foundation intrudes into the sidewalk. The distance from the back of curb to the foundation is 3-ft. This limits the ability of a person in a wheelchair to traverse this area.

Replace or repair.

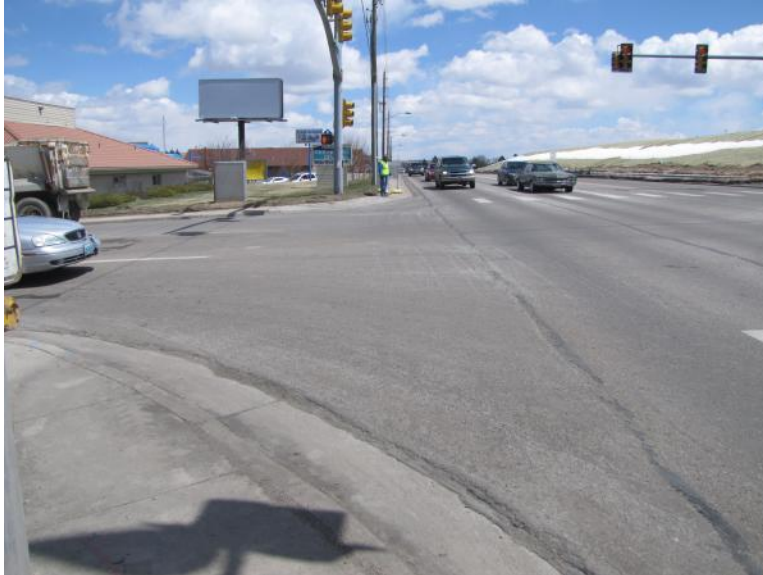
Exhibit 80 North Leg of Intersection from NW Corner

Issue: No Crosswalk Striping on North Leg

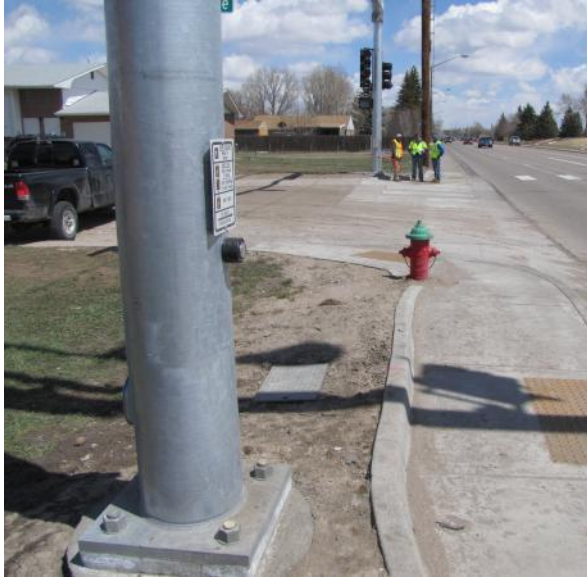
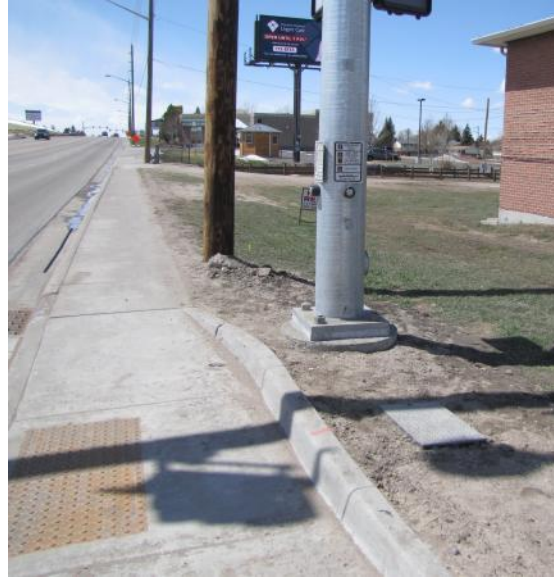
Issue: Inaccessible Push Button

Exhibit 83 Inaccessible Pedestrian Push Button in NW Corner – Looking East

Exhibit 84 Inaccessible Pedestrian Push Button in NW Corner – Looking West

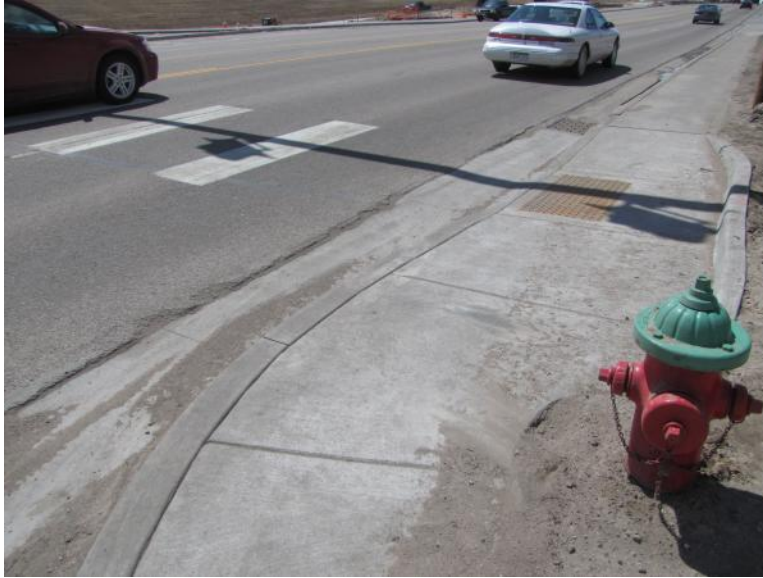
Issue: Sidewalk Width Limited to 3 feet

Exhibit 85 Fire Hydrant Limiting Clear Sidewalk Width

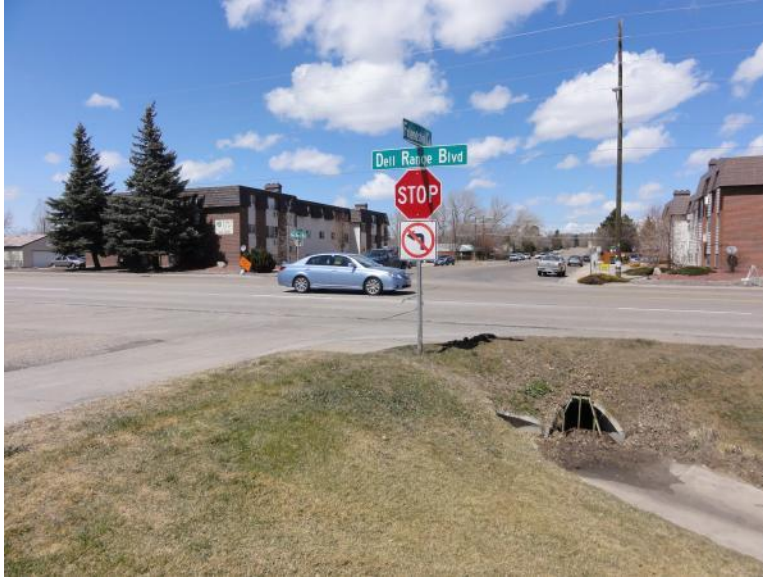
Exhibit 91 Looking Northbound at Friendship Circle

Issue: No Left Turn Sign Not Effective

Drivers were observed making a northbound left-turn from Friendship Circle although a “No Left-turn” sign is posted below the stop sign.

Replace signs

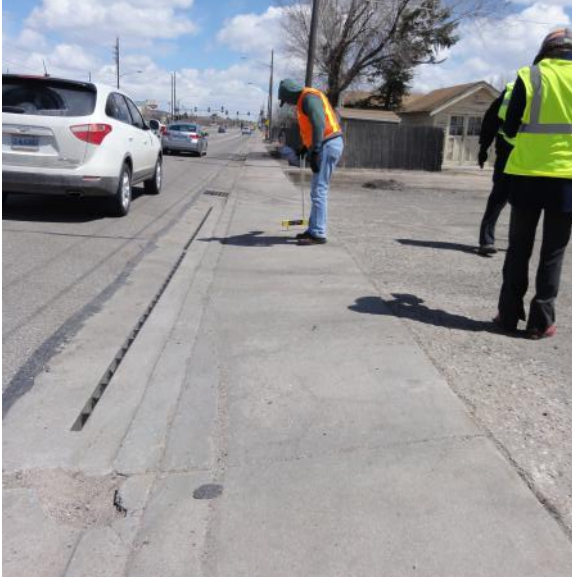
Issue: Sidewalk Cross-Slope

Exhibit 94 Sidewalk Slope on South Side of Dell Range Boulevard

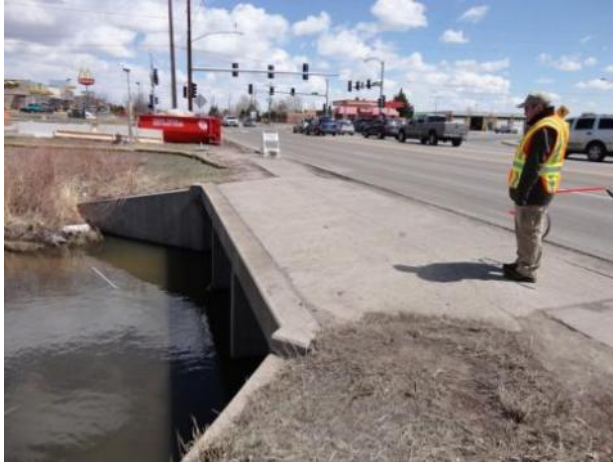
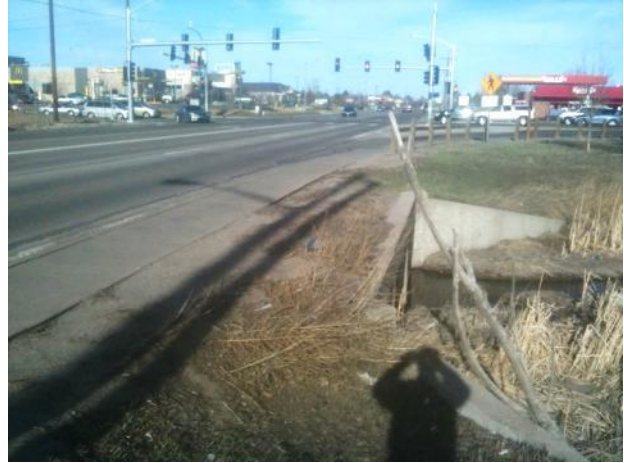
Issue: Dry Creek Box Culvert

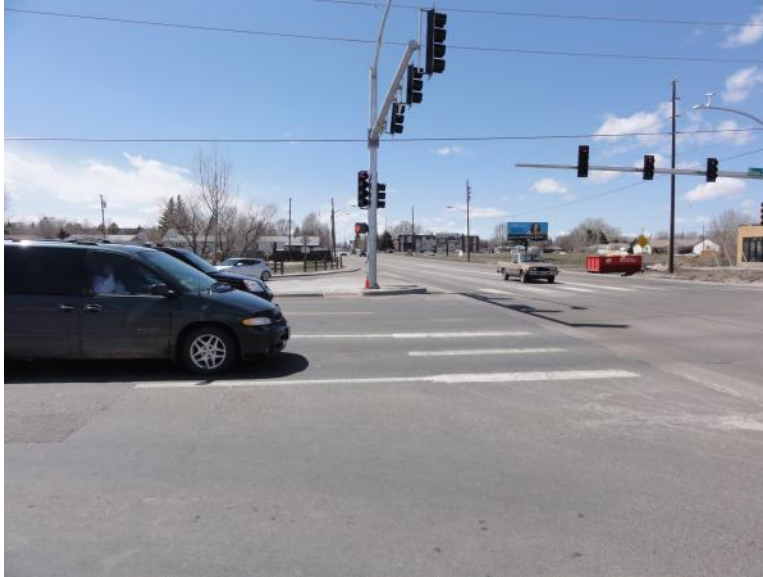
Exhibit 97 Looking West at South Approach

Issue: No Crosswalks on North and South Approaches

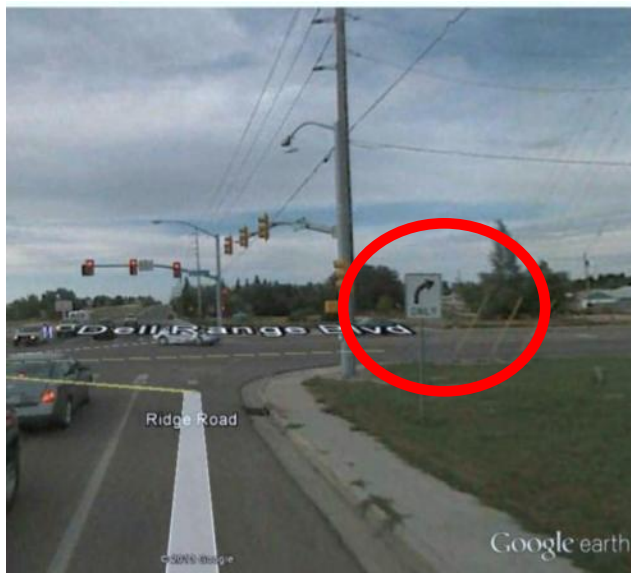
Exhibit 98 Southbound Ridge Road at Dell Range Blvd

Issue: Southbound Right Turn Only sign

Replace sign.

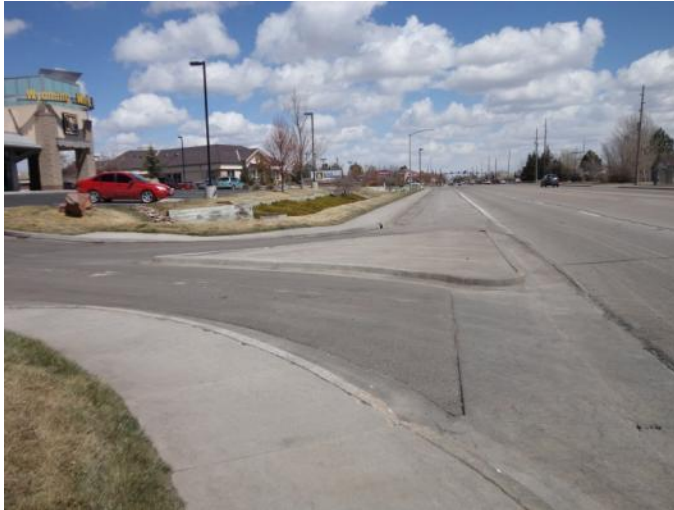
Exhibit 100 Looking East at McDonalds Entrance

Issue: Extended RT lane from King Soopers Entrance to McDonalds Entrance

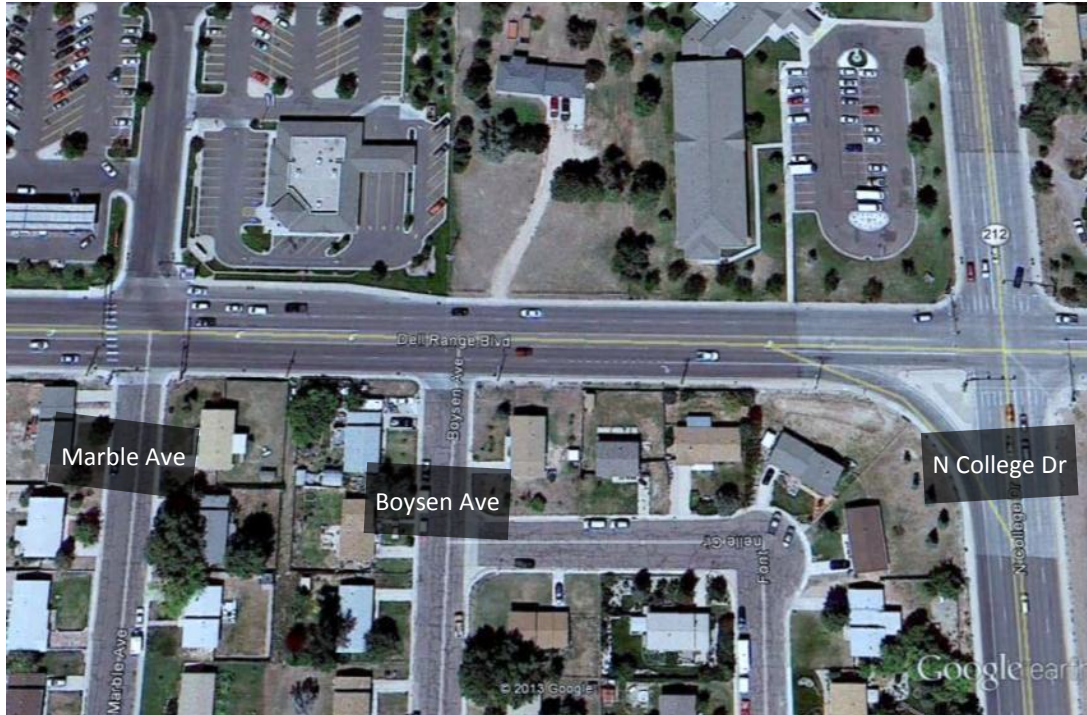
Exhibit 101 Dell Range Boulevard from Marble Avenue to College Drive

Issue: Queue Conflicts at Boysen Avenue

Dell Range Boulevard at College Drive drops and adds a lane in the eastbound and westbound directions respectively. In the PM peak hour, the RSA team observed the eastbound queue at College Avenue to back through the Marble Avenue signal a distance of approximately 725 ft. The queue blocks the full, unsignalized intersection of Boysen Avenue. The residential subdivision has access to Dell Range Boulevard at both Boysen Avenue and the signal at Marble Avenue.

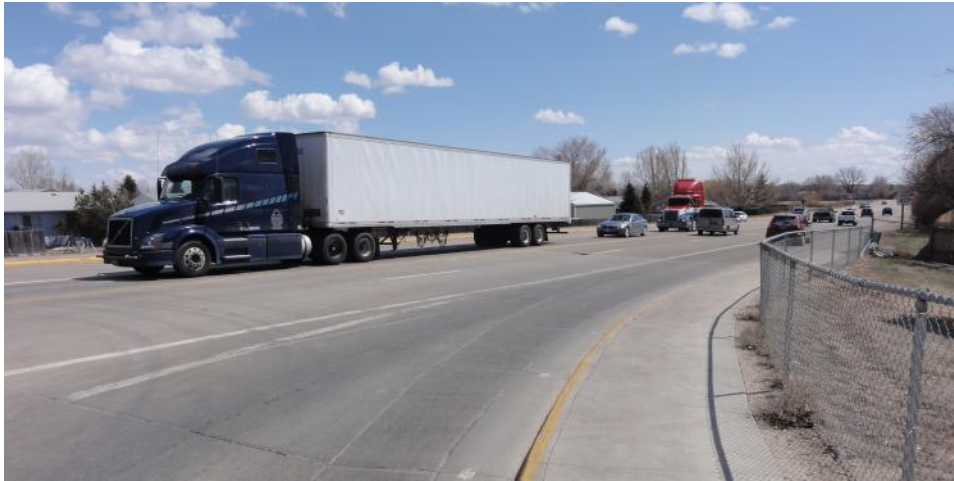
Issue: Northbound Left-turn Capacity

Exhibit 102 Looking South at Northbound Left-turn Lane Queue
