Road Safety Audit Report

Dell Range Boulevard from Powderhouse Road to College Drive & Prairie Avenue from Powderhouse Road to Dell Range Boulevard

June 2013

Field Review Date: April 23 to 24, 2013

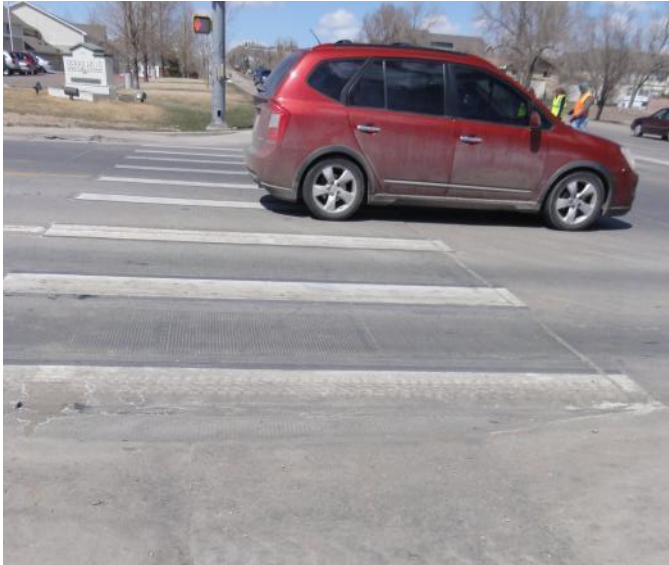
Exhibit 103 Looking North on West Leg

Issue: Pedestrian Signal Push Button Inoperative

Repair or replace pedestrian signal pushbuttons in SW and NW corners of intersection.

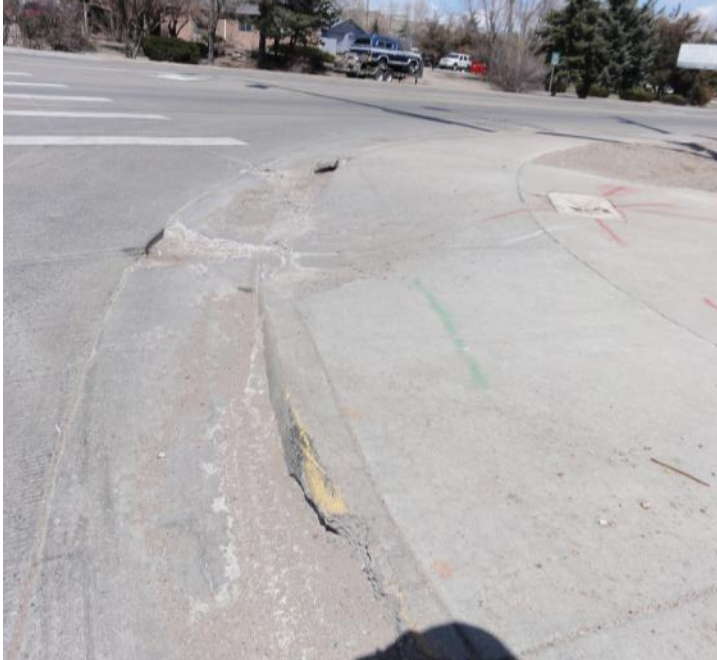
Exhibit 104 Curb in SE Corner

Issue: Curb Radius Too Small

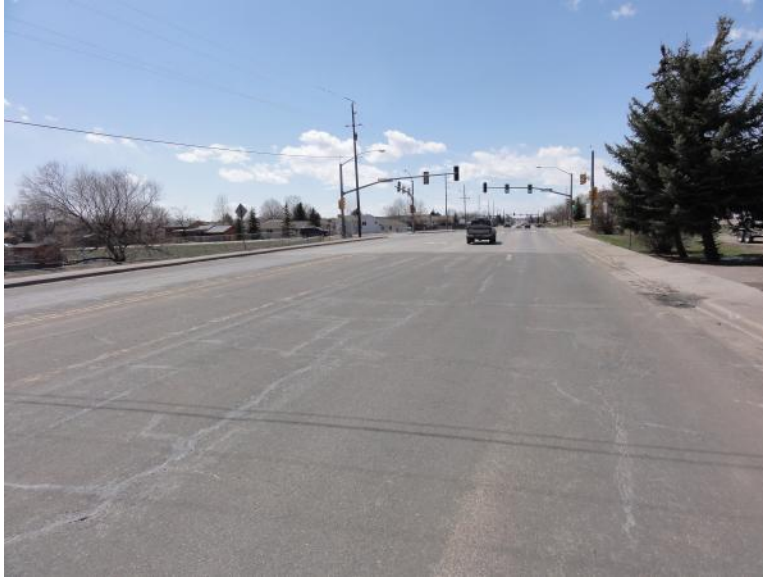
Exhibit 105 Looking West Toward College Drive

Issue: Westbound Lane Striping Missing

Lane striping is worn and not visible between lanes on westbound approach.

Westbound lane striping missing	Dell Range Boulevard/College Drive	Category I	Restripe lane lines on east approach.
Curb higher than sidewalk	Prairie Avenue – Entire Corridor	Category I	As part of other improvements along the corridor, raise the sidewalk to the elevation to match the back of curb.

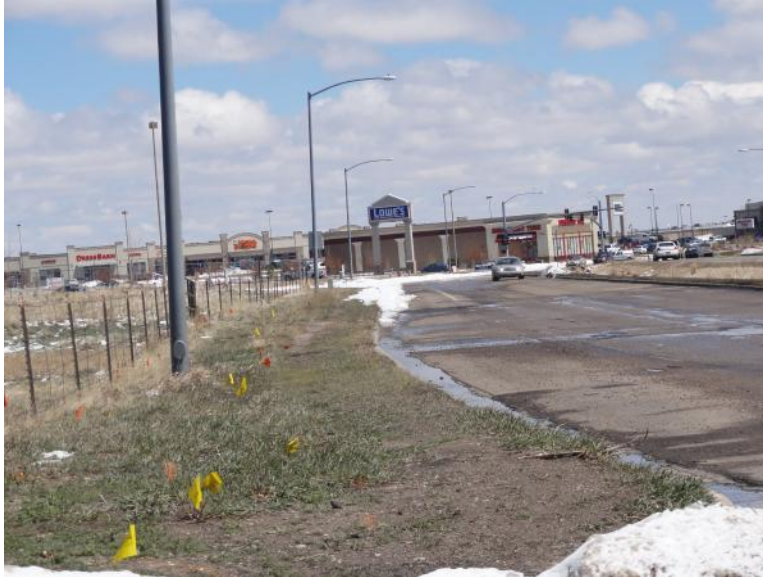
Exhibit 110 Looking East on North Side of Prairie Avenue

Issue: Missing Sidewalk Segment

Issue	Location	Risk Classification	Suggestion
Missing sidewalk segment	Powderhouse Road to Lowes Access	Category I	As these vacant parcels north and east of Prairie Avenue develop, construct sidewalk on north side of Prairie Avenue from Lowes access west to the Point Frontier development.
Pedestrian access to transit stop	Powderhouse Road to Lowes Access	Category I	Provide accessible pedestrian ramps with hard surface connections at the sidewalk and across the median. Provide accessible pedestrian ramps with hard surface connections at the sidewalk and across the median.
Street name sign missing	Prairie Avenue/Lowes Access	Category I	Install street name signs on south and north approach signal mast arms, consistent with those provided at adjacent signalized intersections on Prairie Avenue.
Painted crosswalk into median	Prairie Avenue/Lowes Access	Category I	Provide accessible ramps with a connecting hard surface extending the crosswalk through the median.

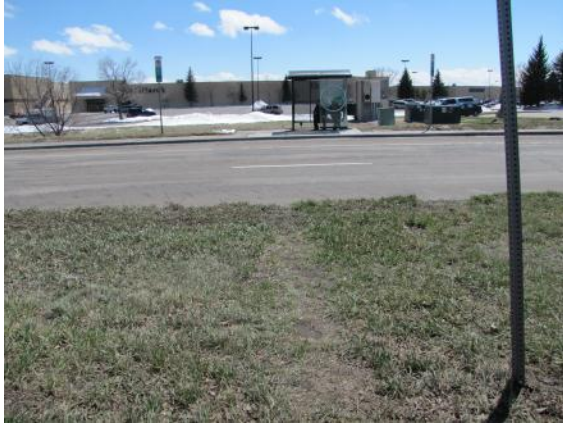
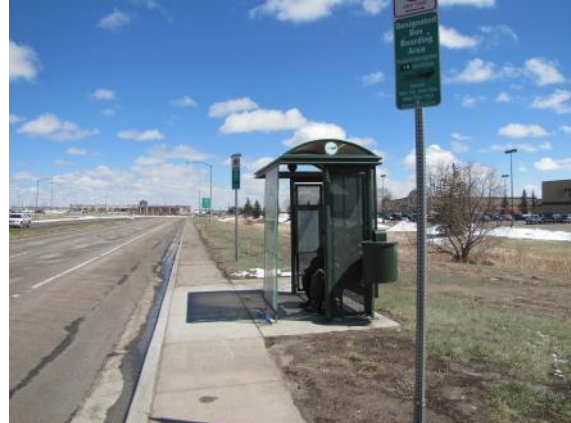
Issue: Pedestrian Access to Transit Stop

Exhibit 111 Worn pathway across median

Exhibit 112 Sidewalk and transit stop on south side of Prairie Avenue

There is a transit stop on the south side of Prairie Avenue and apartments on the north side. There is an identified worn pedestrian foot path across the median of Prairie Avenue. There is not a handicapped ramp at the transit stop nor provisions for handicapped accessibility across the median.

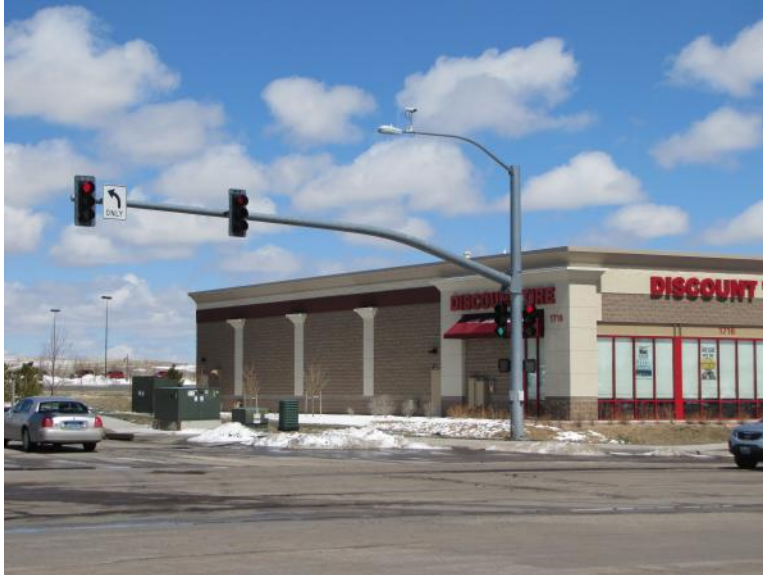
Exhibit 113 Looking North from the South Approach at Lowes Access

Issue: Street Name Sign Missing

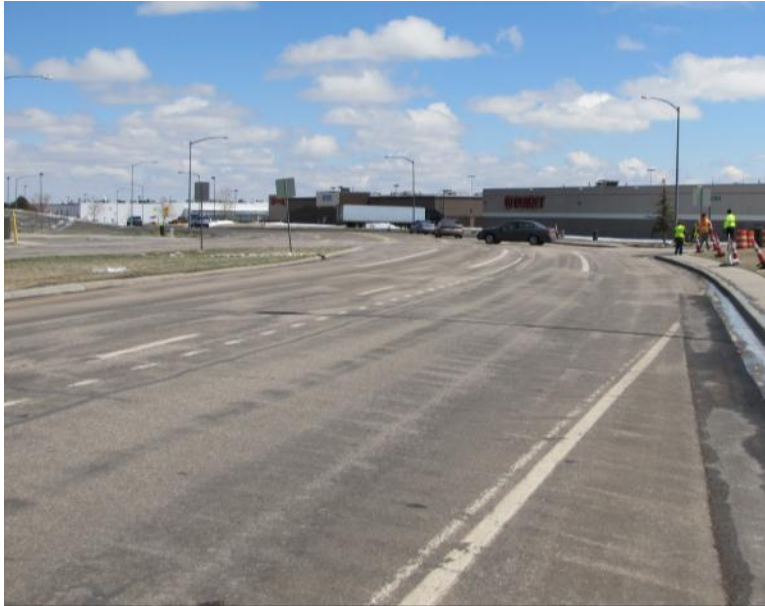
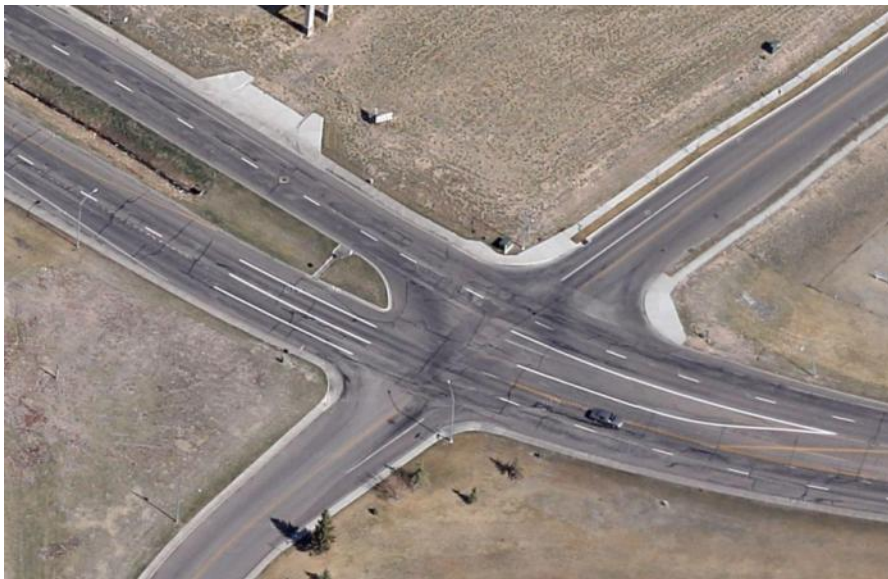
Issue: Eastbound Lane Channelization

In the near-term consider adding lane line extensions through the intersection (see Exhibit 118) and/or realigning eastbound approach to provide short tangent section aligning drivers into their respective lanes on the downstream side of intersection. In the long-term consider reconstructing median and curb to reinforce the approach alignment.

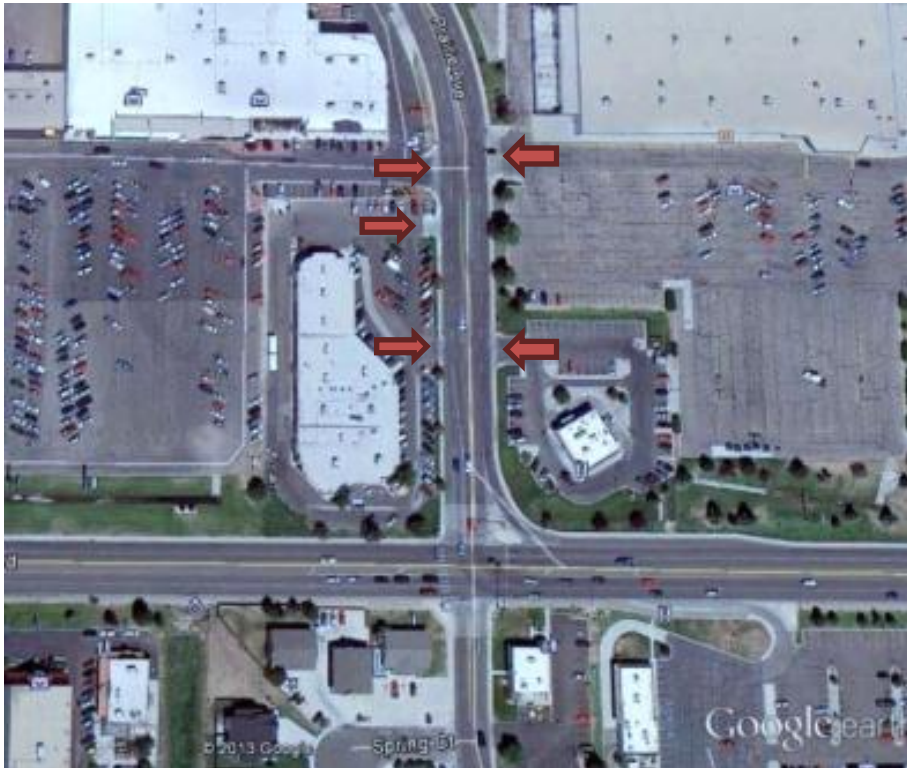
Exhibit 121 Multiple driveways on Prairie Avenue north of Dell Range Blvd.
