Road Safety Audit Report

Dell Range Boulevard from Powderhouse Road to College Drive & Prairie Avenue from Powderhouse Road to Dell Range Boulevard

June 2013

Field Review Date: April 23 to 24, 2013

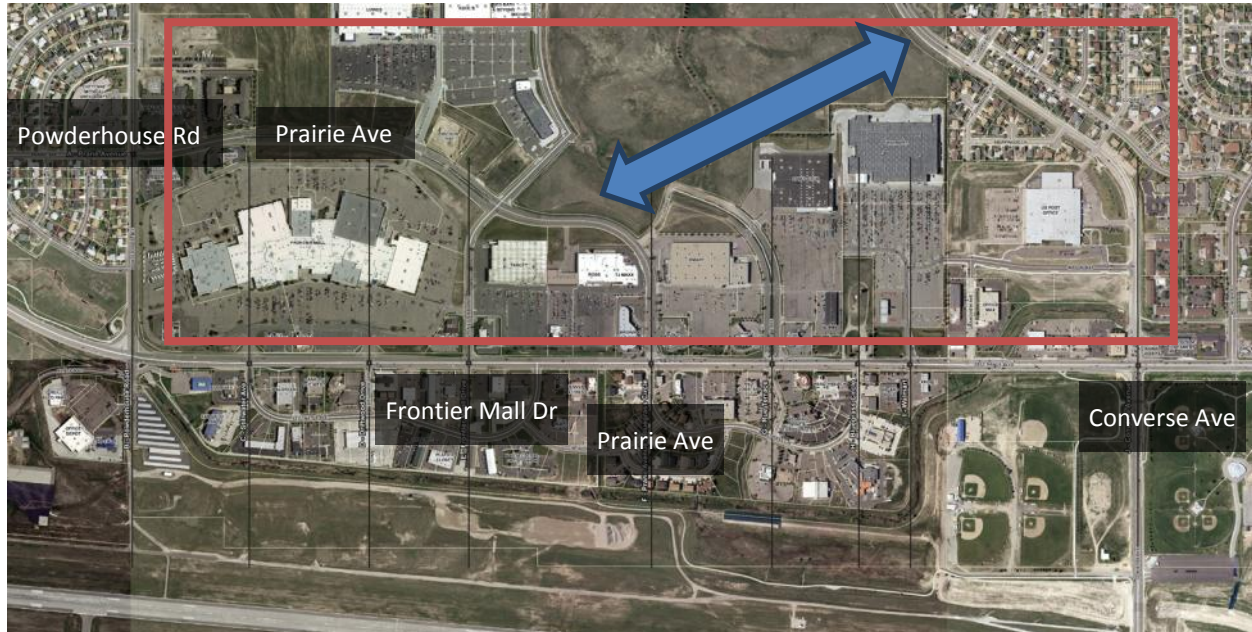
Exhibit 1 General Area North of Dell Range Boulevard

Issue: East-west Connectivity North of Dell Range Boulevard

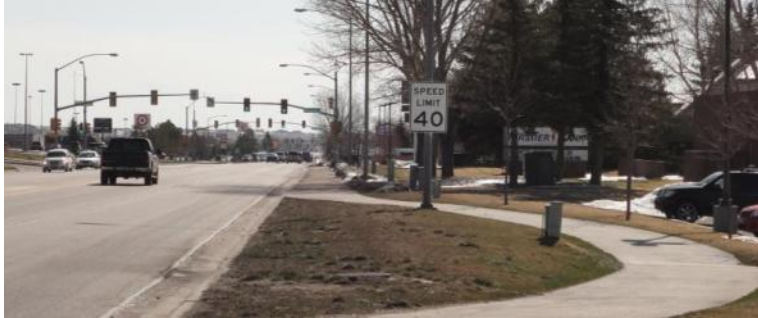
Exhibit 2 Posted Speed Limit Sign

Issue: Travel Speed

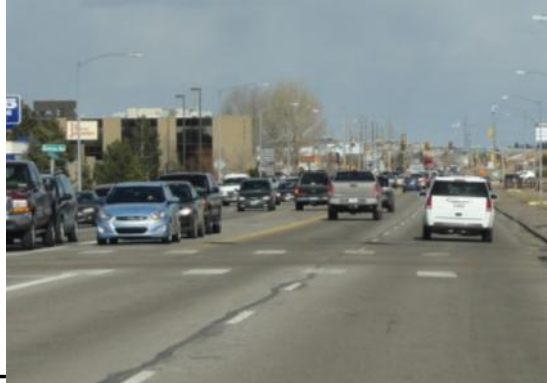
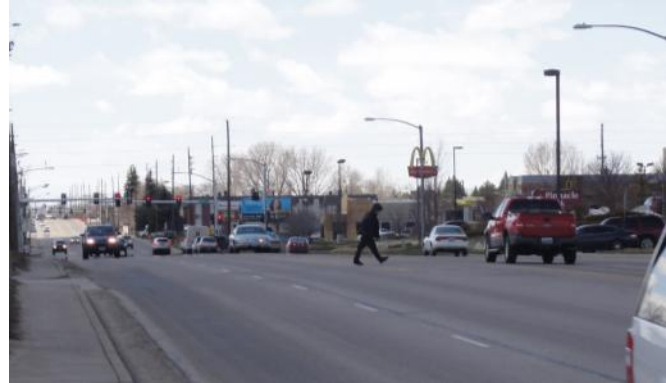
Issue: Existing Median Two-Way Left-Turn Lane

Exhibit 3 Existing Two-Way Left-Turn Lane

Exhibit 4 Pedestrian Crossing Through Existing Two-Way Left-Turn Lane

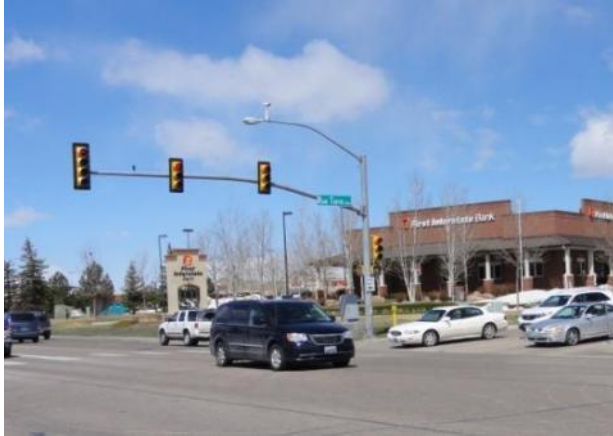
Exhibit 5 Vehicle Entering Intersection on Red Signal

Issue: Red Light Running

The RSA team observed multiple drivers entering the intersection after the red indication had occurred. Over the study period, 203 angle crashes have been reported at signalized intersections. The proportion of those angle crashes that involved a red-light running vehicle are not identified in the crash data, but red-light running is a contributing factor in angle crashes. The RSA team measured the yellow clearance intervals to be 3- to 3.5-seconds at some intersections. Most locations have a one second all red interval.

Function	Classification	Reasoning
Exposure	Category II	RSA team observed this behavior at multiple locations
Probability	Category II	Angle crashes at intersections
Consequence	Category III	Angle crashes typically have injuries
<i>Overall</i>	<i>Category II</i>	-

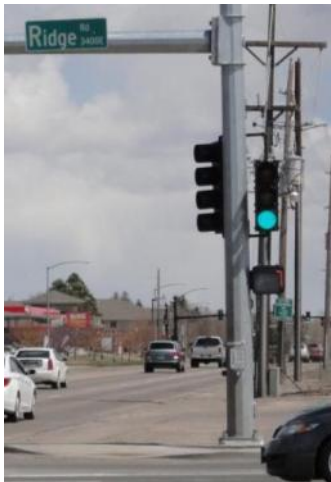
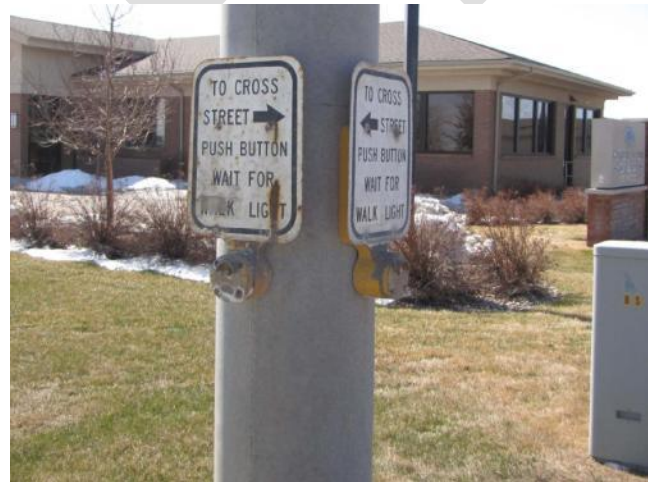
Issue: Countdown Pedestrian Signals

Exhibit 8 **Example of Pedestrian Countdown Signal at Ridge Road**

Exhibit 9 **Example of Pedestrian Push Button and Sign**

The newer signals at Moran Avenue and Ridge Road have countdown signals on all approaches. The other signalized intersections have the older style pedestrian signal indications without countdown (See Exhibit 10). The RSA team also noted many of the pedestrian push button detectors and the pedestrian actuation signs are aged and some are not legible.

Upgrade the other signalized intersections with countdown pedestrian signals and upgrade the pedestrian push button detectors and pedestrian actuation signs for all signalized crosswalks as part of the overall corridor improvement project.

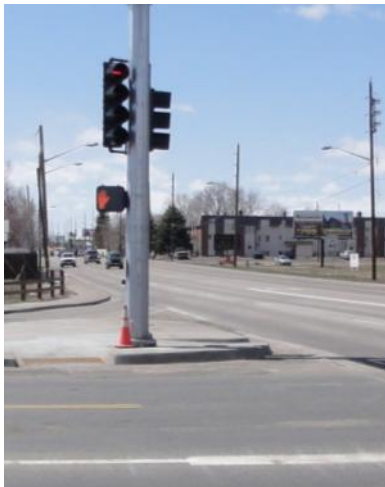
Exhibit 11 Pedestrian Signal

Issue: Pedestrian Walk Times

Consider increasing the Flashing Do Not Walk time for the Dell Range Boulevard crosswalks to provide for a 3.5 feet per second walking speed and the Walk interval time to be a minimum of 7 seconds. This could be done as part of an overall corridor retiming project done with the previous speed limit reduction consideration.

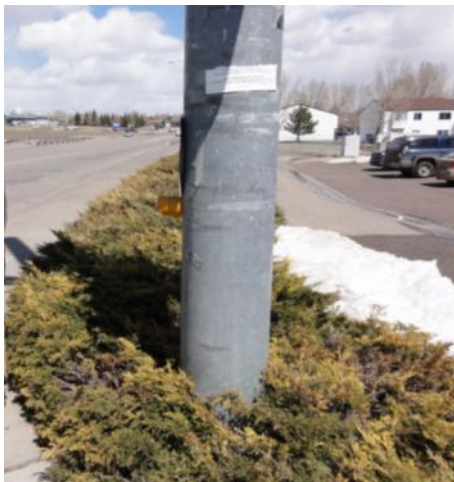
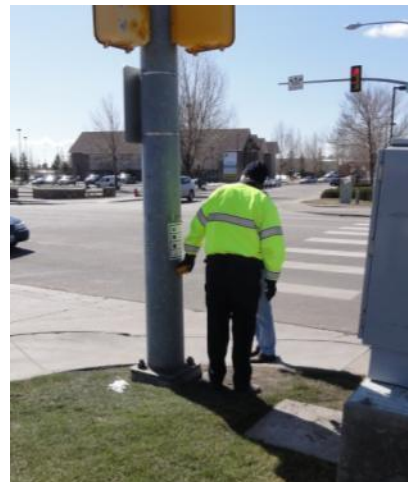
Issue: Accessible Pedestrian Facilities

Exhibit 12 Pedestrian Push Button in NE Corner of Dell Range/Converse Intersection

Exhibit 13 Pedestrian Push Button in NW Corner of Dell Range/Rue Terre Intersection

Multiple design elements do not meet ADA requirements. Observed design elements that do not meet ADA requirements include:

Function	Classification	Reasoning
Exposure	Category I	
Probability	Category II	Issues noted frequently throughout corridor
Consequence	Category III	Vulnerable user
<i>Overall</i>	<i>Category II</i>	-

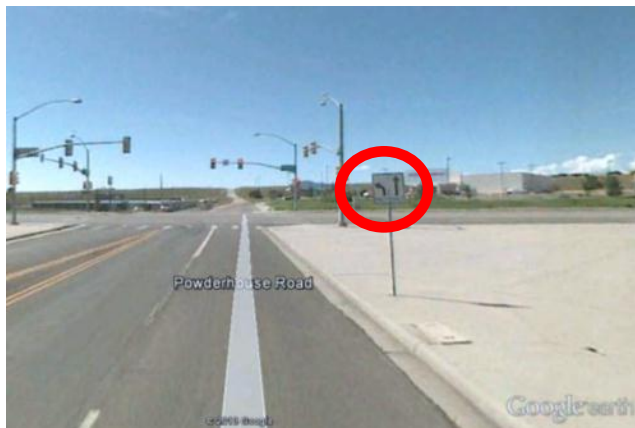
Exhibit 14 Southbound Approach at Powderhouse Road/Dell Range Boulevard Intersection

Issue: Southbound Channelization Sign – Poor Retro-Reflectivity

Replace sign.

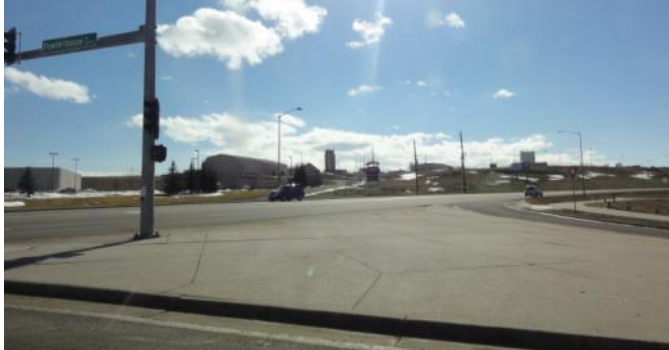
Exhibit 15 Southbound Right-Turn Lane at Dell Range Boulevard/Powderhouse Road

Issue: SB Right Turn Lane

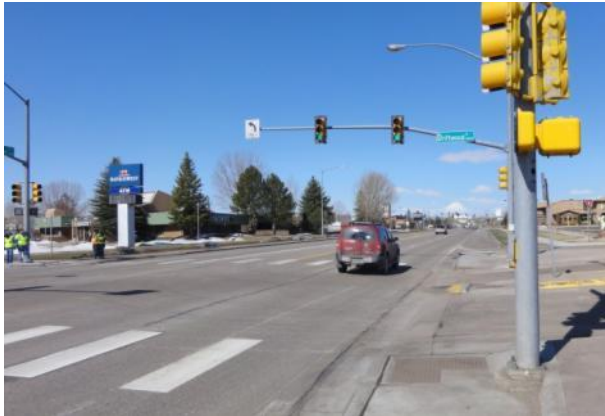
**Exhibit 24 Looking West from the Northeast
Corner at Driftwood**

Issue: Intersection Volume May Not Warrant Signal

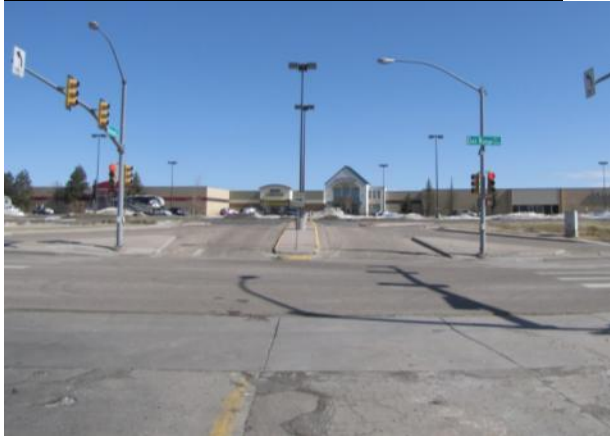
Exhibit 25 Looking North from Northbound Approach

Issue: No Overhead Signal for NB Approach

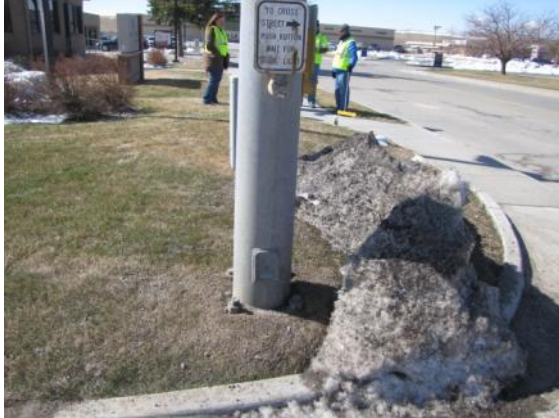
Exhibit 26 Pedestrian Push Button in SE Corner of Intersection

Issue: Pedestrian Push Buttons Accessibility

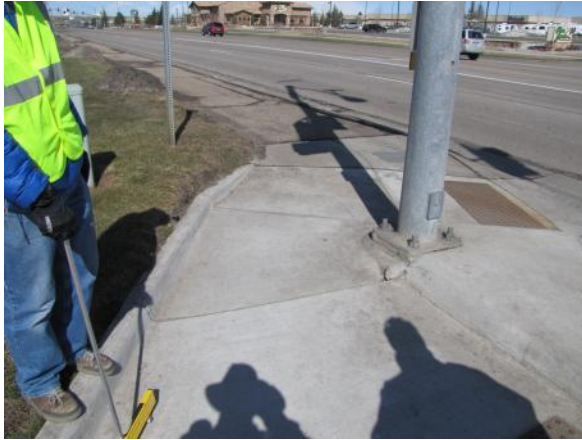
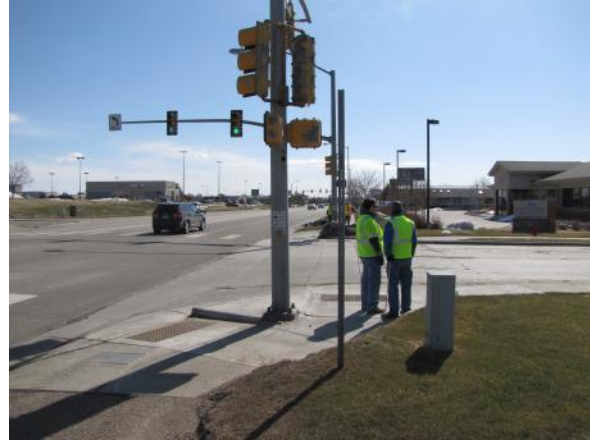
Issue: Sidewalk Width in SW Corner

Exhibit 27 Sidewalk Between Signal Pole and Curb

Exhibit 28 Intersection SW Corner

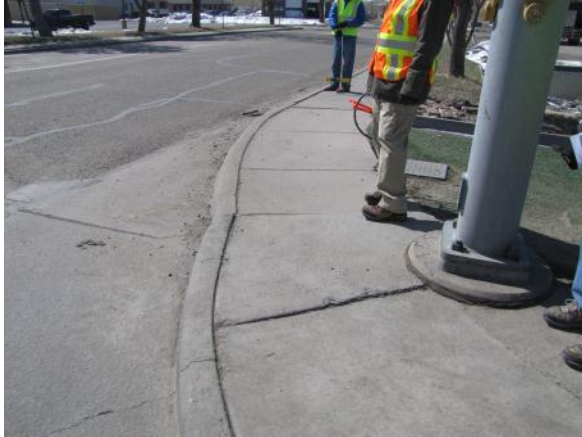
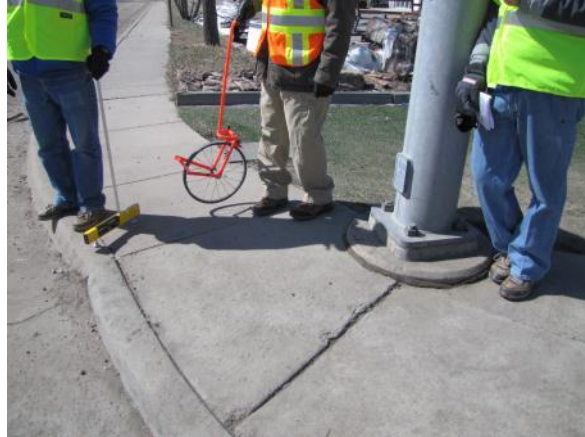
Issue: Sidewalk Width Near Signal Pole – SW Corner

Exhibit 31 Sidewalk Width Near Signal Pole is 3'-6"

Exhibit 32 Sidewalk Width Near Signal Pole is 3'-6"

Sidewalk width is 3'-6" from back of curb to the face of the signal pole foundation. This minimum should be 4-ft for traversing by a wheelchair.

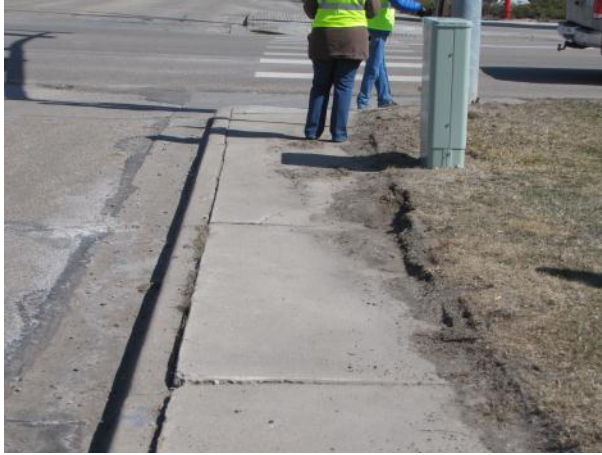
Issue: Dirt Blocking Sidewalk

Exhibit 33 Dirt Blocking Sidewalk – SW Corner

Dirt has spilled into the sidewalk reducing the effective width to less than 4-ft and creating a potential tripping hazard for pedestrians.

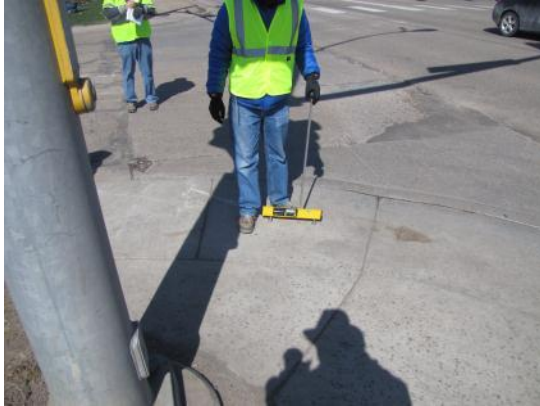
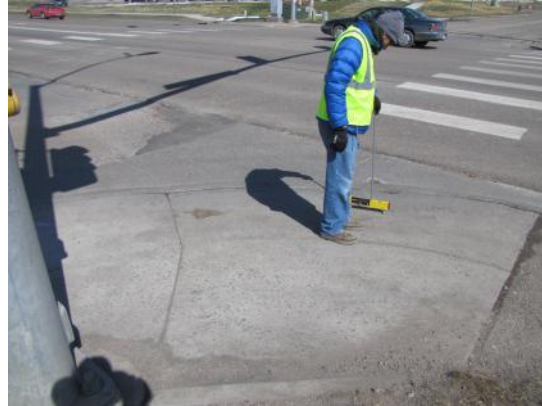
Issue: Accessible Ramp Slopes

Exhibit 35 **Slope of Pedestrian Ramp in SW Corner**

Exhibit 36 **Slope of Pedestrian Ramp in SW Corner**

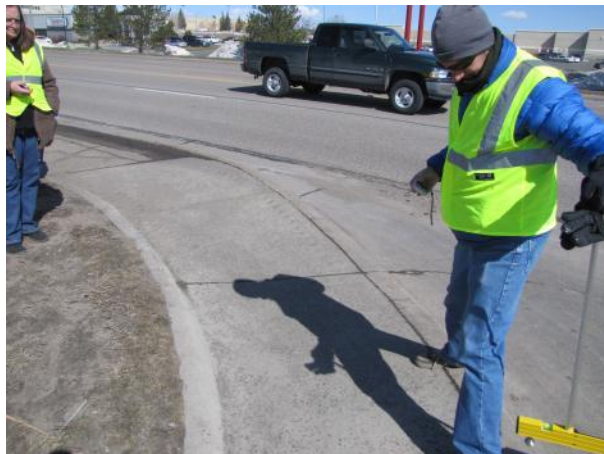
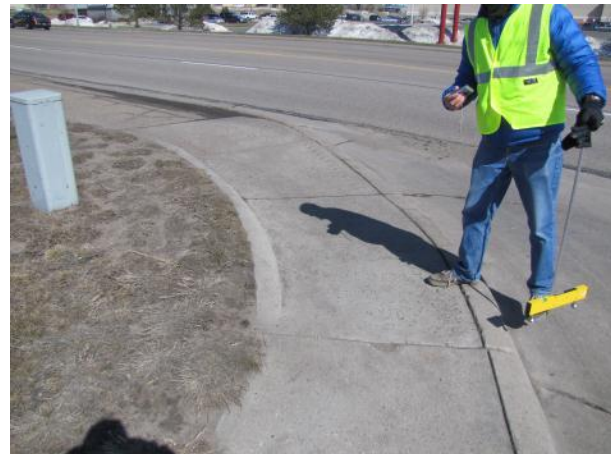
Issue: Sidewalk Width and Slope – SW corner

Exhibit 39 Sidewalk in SW Corner

Exhibit 40 Sidewalk in SW Corner

Upgrade ramp to provide slopes less than 8.3%, a minimum of 4-ft width and detectable warning devices/truncated domes.

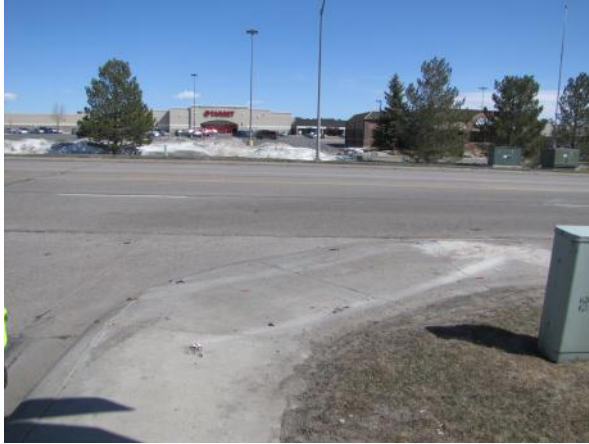
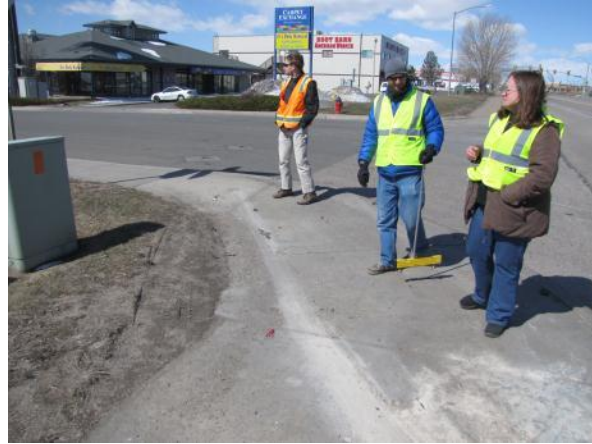
Issue: Accessible Pedestrian Ramp Sloped Toward ROW Line

Exhibit 41 Accessible Pedestrian Ramp in SW Corner (from south)

Exhibit 42 Accessible Pedestrian Ramp in SW Corner (from east)

Repair sidewalk to remove depression and drain to street.

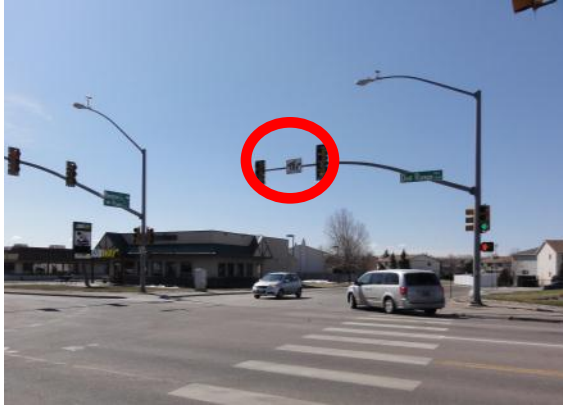
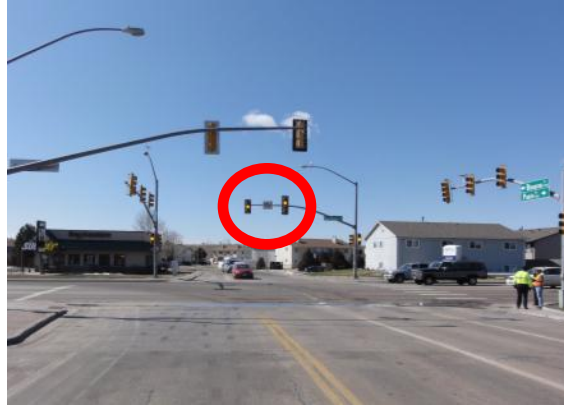
Issue: Low Reflectivity on Southbound Approach Signage

**Exhibit 45 Southbound Approach –
Channelization Sign between
Signal Heads**

**Exhibit 46 Southbound Approach –
Channelization Sign between
Signal Heads**

Replace the sign with a ground-mounted sign in advance of the intersection.

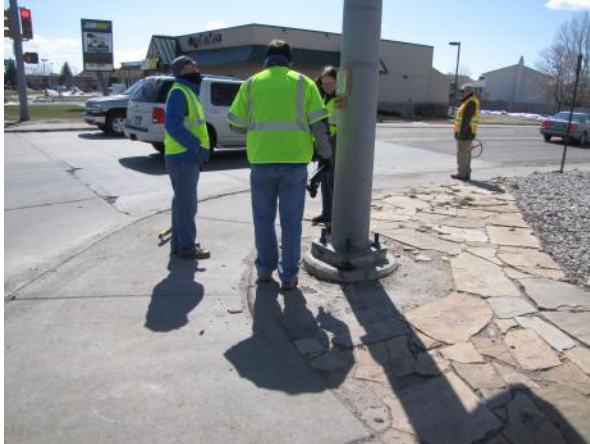
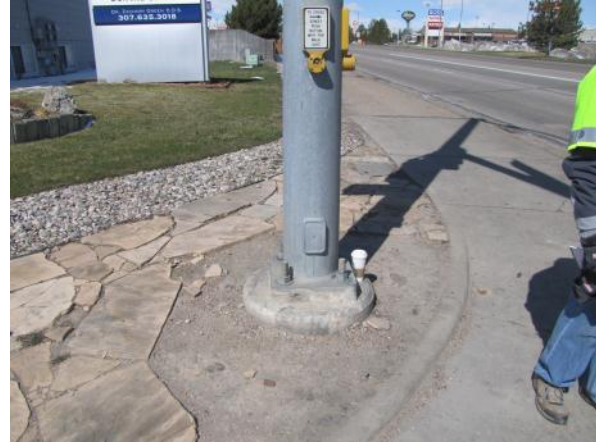
Issue: Inaccessible Pedestrian Push Button

Exhibit 47 SW Corner – Pedestrian Push Buttons

Exhibit 48 SW Corner – Pedestrian Push Buttons

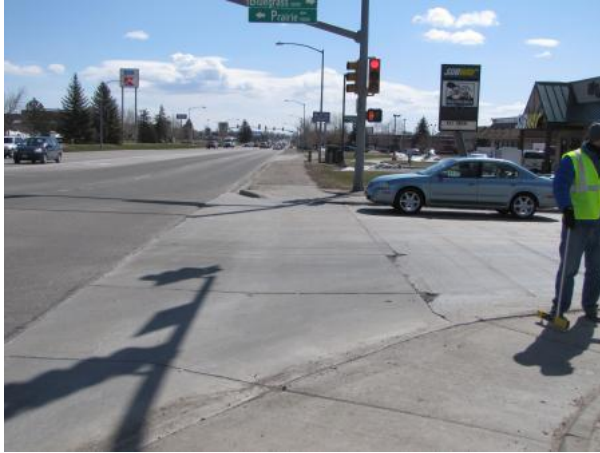
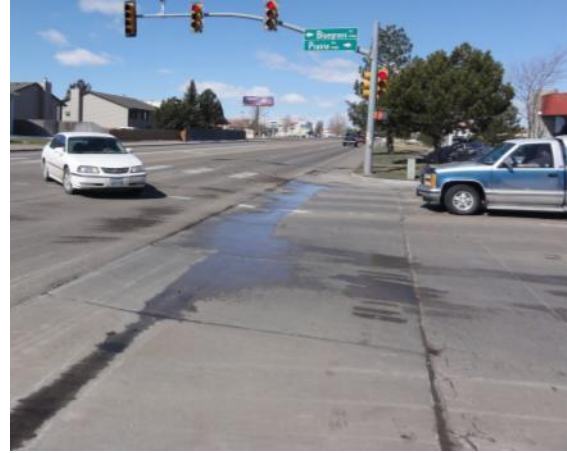
Issue: South Approach - Crosswalk

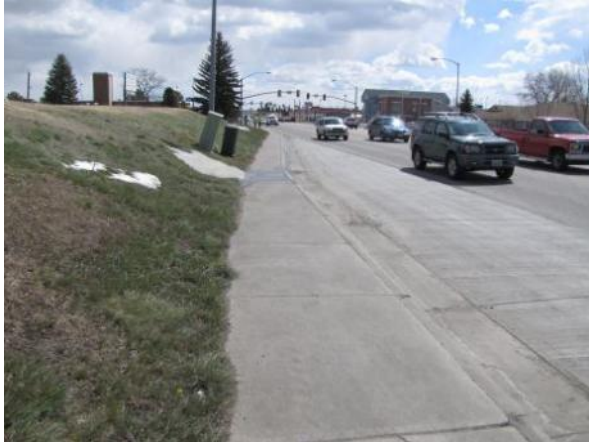
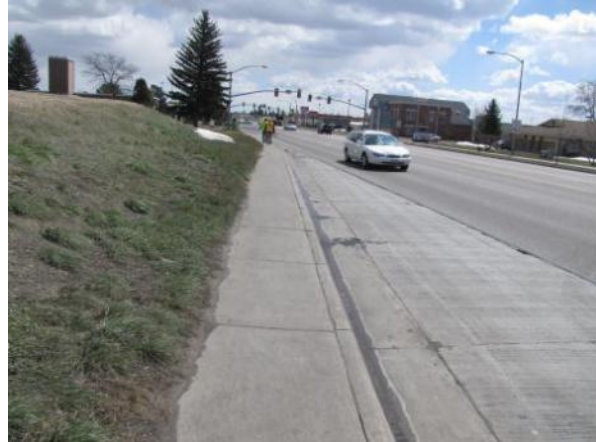
Issue: Enbankment narrows sidewalk

Exhibit 57 North Side Looking East

Exhibit 58 At EB Right Turn Lane Taper to Rue Terre

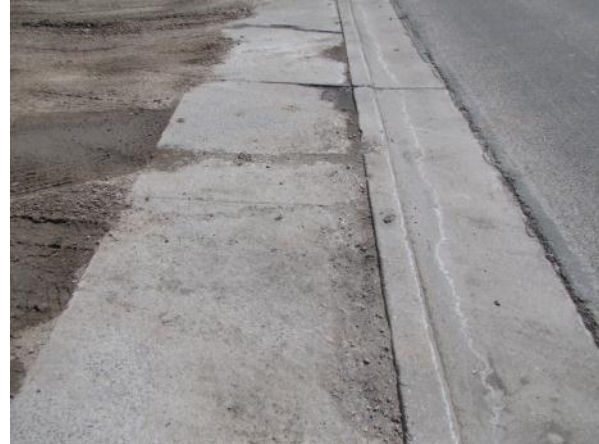
Issue: Sidewalk/Driveway Surface Condition

Exhibit 60 Driveway/Sidewalk west of Fire Station

The driveway serving a dirt road to the north and behind the fire station also serves as a sidewalk. This driveway/sidewalk has become cracked and is ponding water. The joints have become uneven. Crossing this area as a pedestrian could be difficult especially if in a wheelchair.

Repair cracked concrete driveway/sidewalk. Consider extending driveway paving to the north to minimize the dirt getting onto the sidewalk.

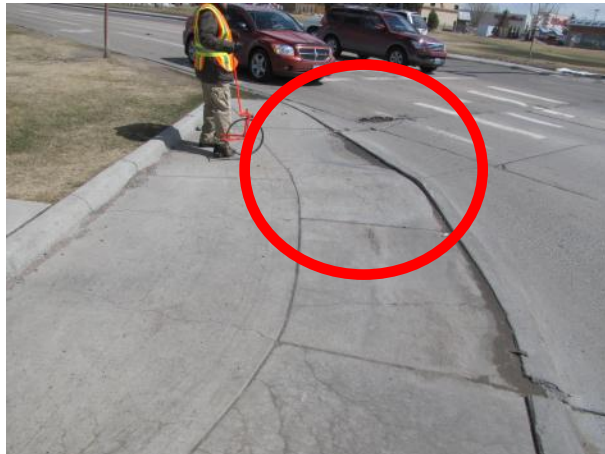
Exhibit 63 Northwest Corner Pedestrian Ramps

Issue: Inaccessible Pedestrian Ramp

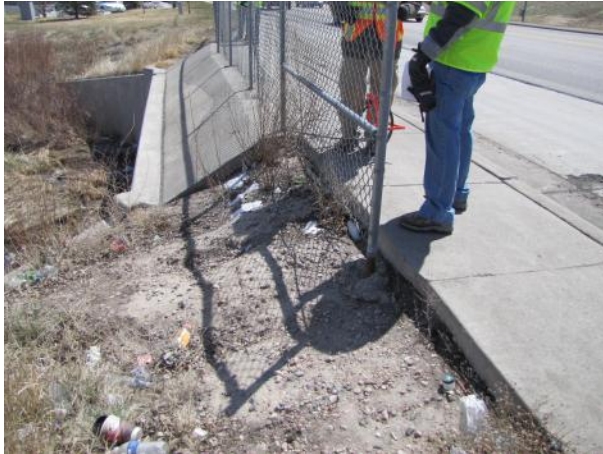
Issue: North Side Sidewalk Drop-Off

Exhibit 68 North side – sidewalk drop-off at box culvert – west of culvert

Extend the limits of the fence and repair fence.

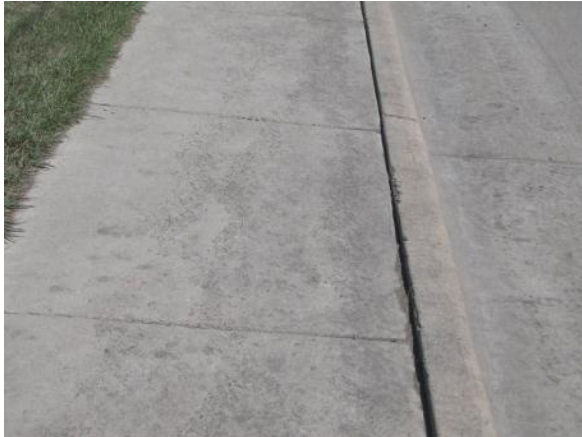
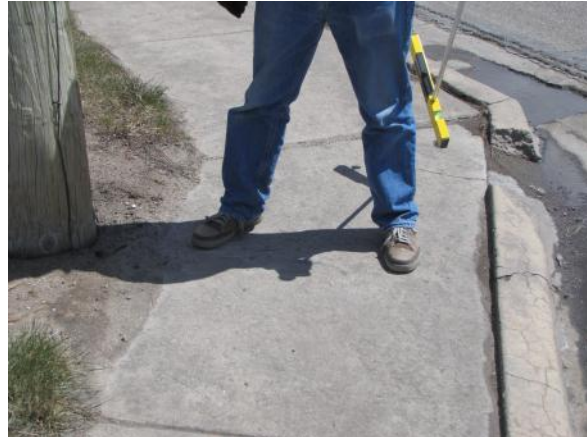
Issue: Curb Higher than Sidewalk

Exhibit 81 North Side Sidewalk

Exhibit 82 North Side Sidewalk

The sidewalk in front of the “New Concept – Optical & Eyecare” has the curb higher than the sidewalk. In some locations, this separation was over 1”. This can cause pedestrians to trip.

Repair sidewalk to match back of curb.

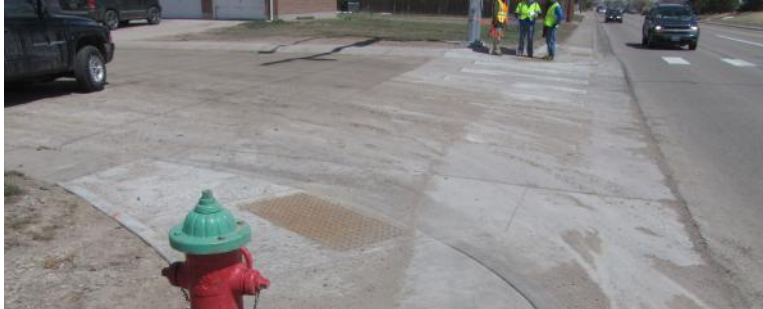
Issue: Cross Slope of Moran Avenue

Exhibit 86 Looking East from NW Corner at Moran Avenue

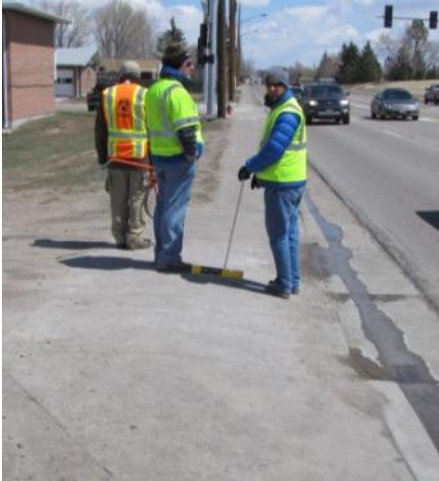
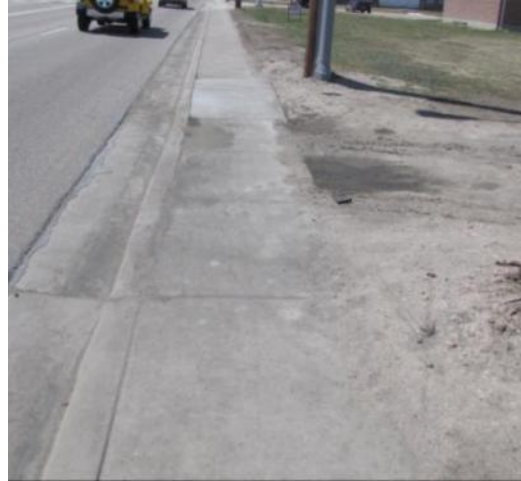
Issue: Cross Slope at Public Streets

Exhibit 87 Looking East at Driveway Cross-Slope at Greybull Avenue

Exhibit 88 Looking West at Driveway Cross-Slope at Sagebrush Avenue

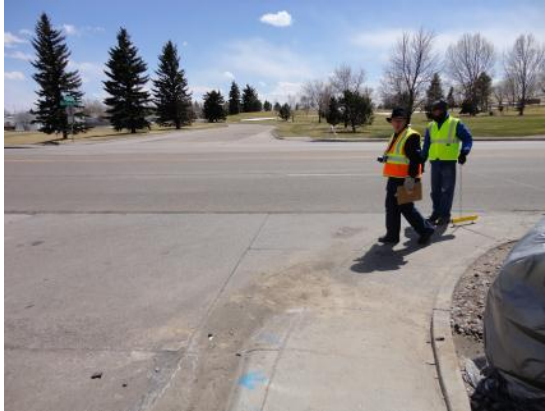
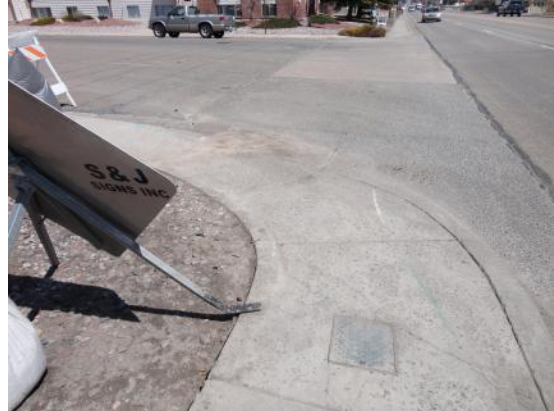
Issue: No Pavement Markings on Southbound Approach

Exhibit 89 Hilltop Avenue looking south

Exhibit 90 Looking east at Hilltop Avenue north approach

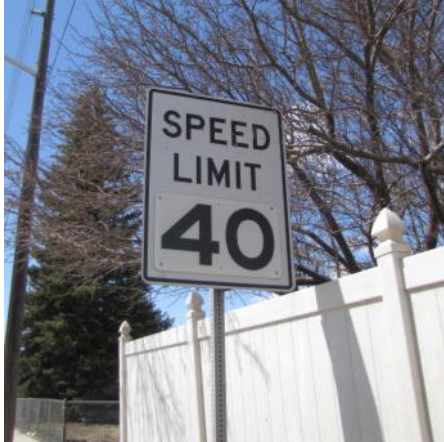
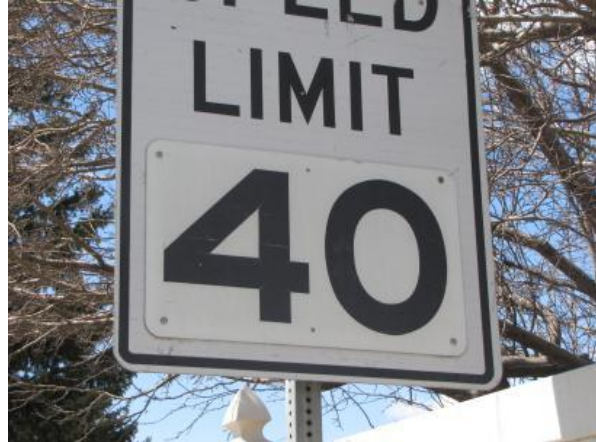
Issue: Low Reflectivity Speed Limit Signs

Exhibit 92Speed Limit sign

Exhibit 93Panel to change speed limit

Replace signs

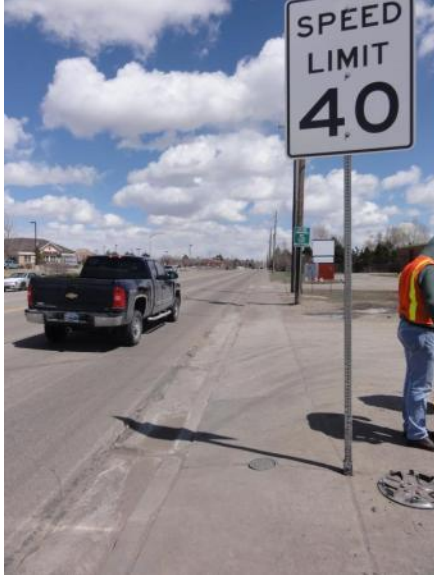
Issue: Sidewalk Cross-Slope

Exhibit 99 Sidewalk Slope on South Side of Dell Range Boulevard

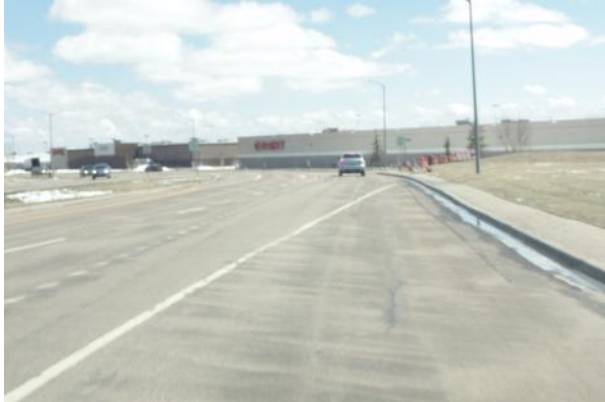
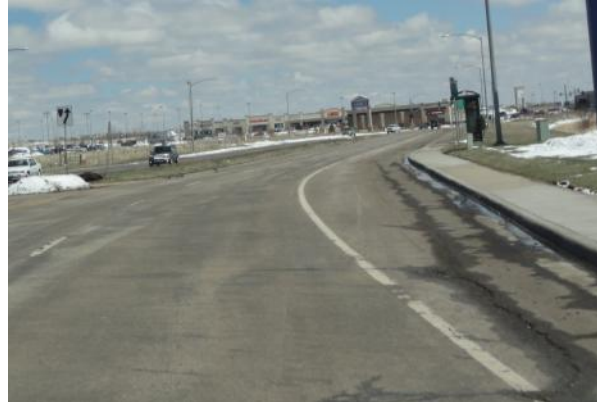
Issue: Excess Pavement Width

**Exhibit 106 West of Frontier Mall Drive
Looking East**

**Exhibit 107 Eastbound Lanes Looking East
Near Frontier Mall Entrance
(West)**

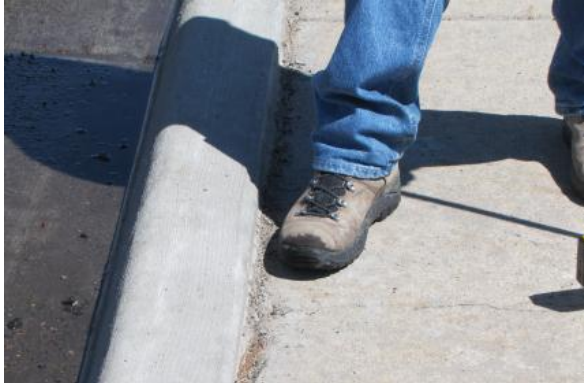
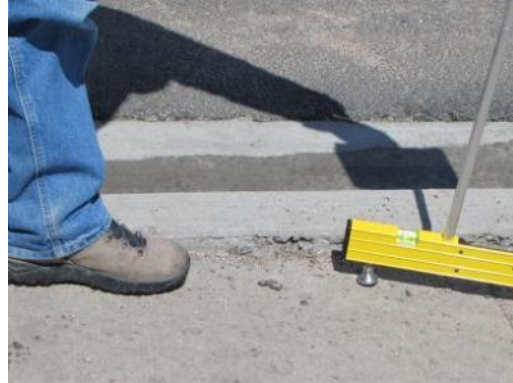
Issue: Curb Higher Than Sidewalk

Exhibit 108 South Side of Prairie Ave West of Transit Stop

Exhibit 109 South Side of Prairie Ave East of Lowes Access

Westbound lane striping missing	Dell Range Boulevard/College Drive	Category I	Restripe lane lines on east approach.
Curb higher than sidewalk	Prairie Avenue – Entire Corridor	Category I	As part of other improvements along the corridor, raise the sidewalk to the elevation to match the back of curb.

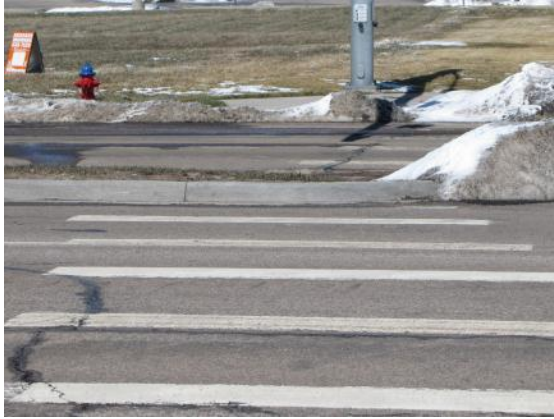
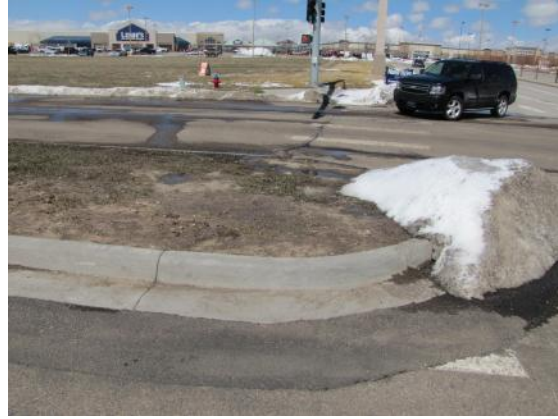
Issue: Painted Crosswalk into Median

Exhibit 114 West Approach Crosswalk

Exhibit 115 Median at West Approach Crosswalk

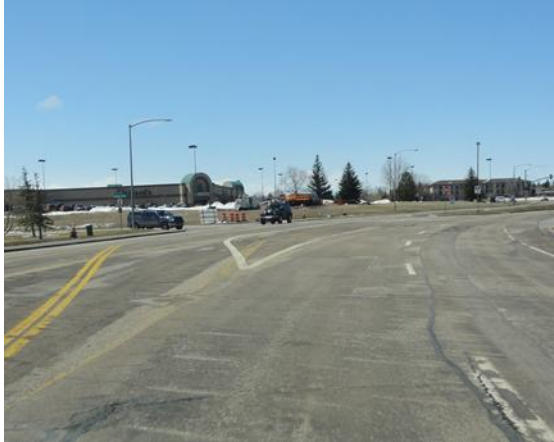
Issue: Intersection geometry

Exhibit 119 Westbound Lanes at Frontier Mall Drive

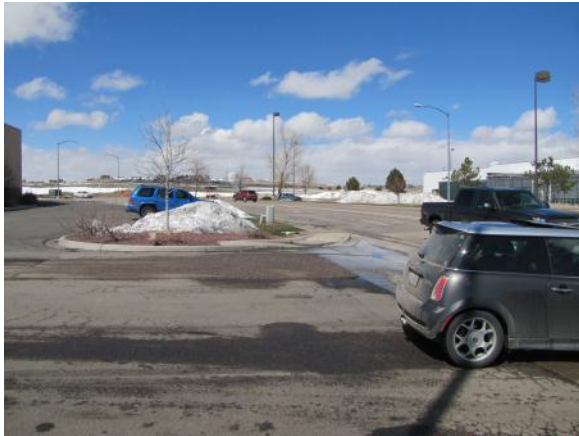
Issue: Access Management

Exhibit 120 PETCO driveway – View to left limited w/curve and parked vehicles
